1948 "Rocket" Train Wreck & Others In & Around Kremlin OK Arrel & Myron Toews

Train Wrecks In and Around Kremlin OK

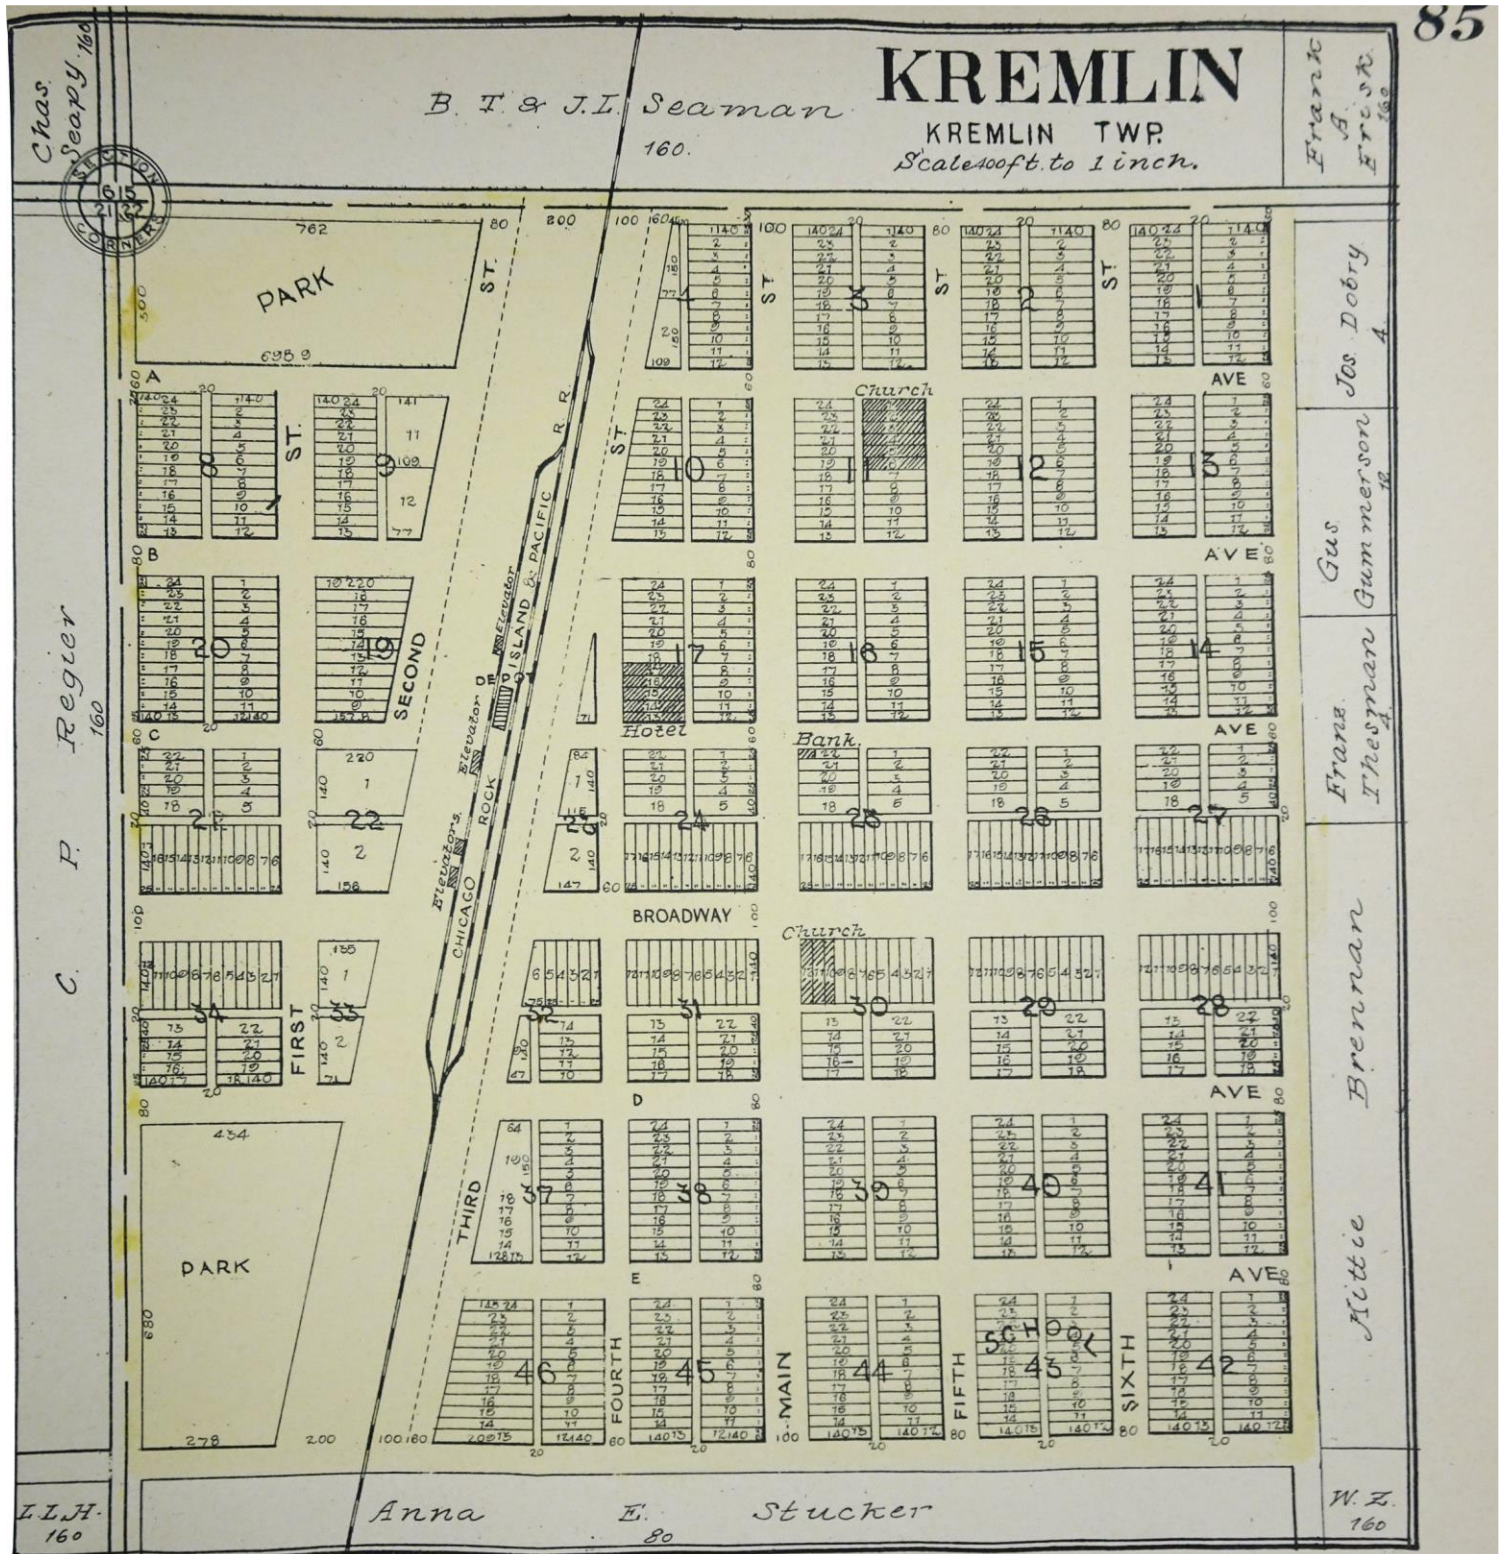
1906 Plat Map of Kremlin Town

A 1906 plat map of the town of Kremlin (Standard Atlas of Garfield County Oklahoma; Geo A Ogle & Co, Chicago, 1906) is shown below for orientation purposes. Note the CRIP tracks running SSW to NNE through the town, with the house track to the W and the passing track to the E of the central main line. The location of the depot is also indicated. Four grain elevators are shown W of the house track by the depot. Also note a hotel, bank and 2 churches in town.

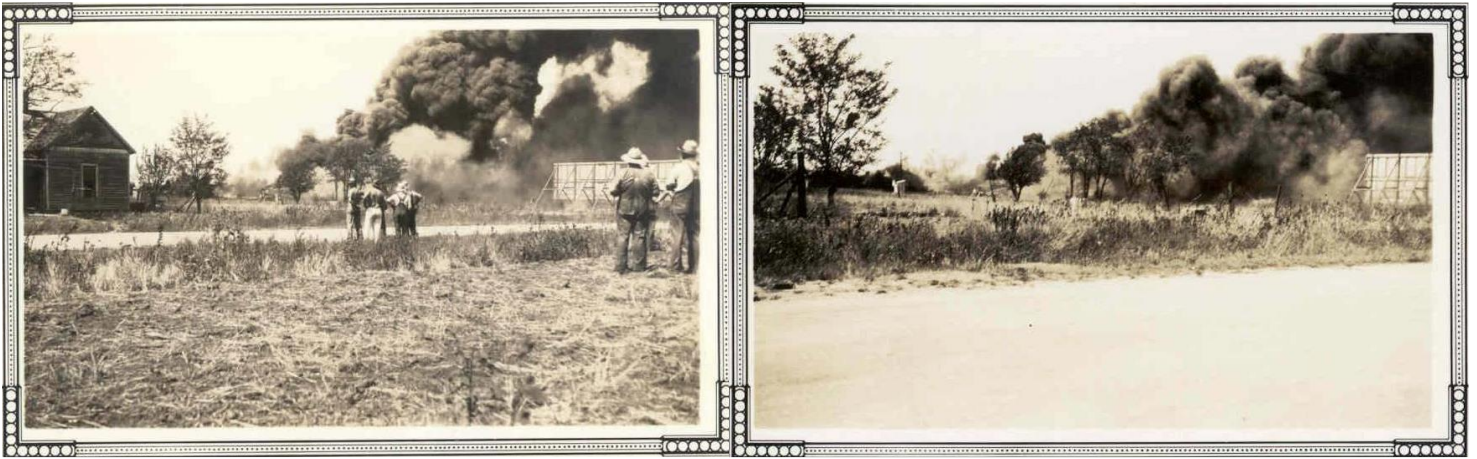
Above, L, Kremlin locals viewing the fire; R, close-up of same view from the road shown at left (inverted from original print) White patches in left photo above may be flames.

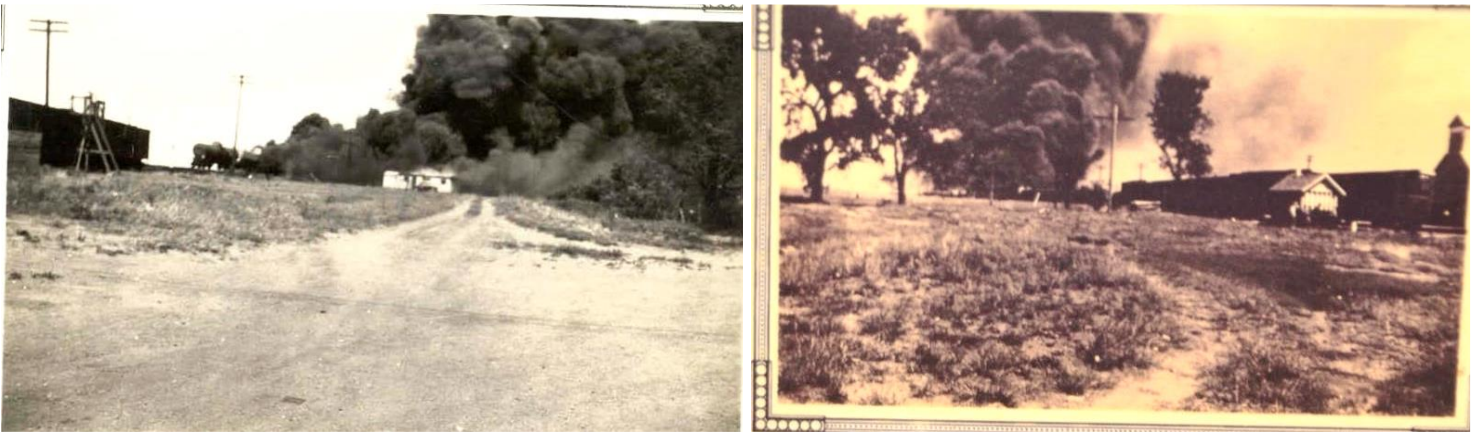
Above: Two additional views of the derailment and fire. Photo at L, looking NNW, shows final two derailed cars (they did not burn) and the rear of the freight train at extreme left. 150' separated them. Photo at R (**FWZ BLDG**) is looking NNE towards tracks and Farmers Grain elevator from W of the depot. Note the fire is N of the depot.

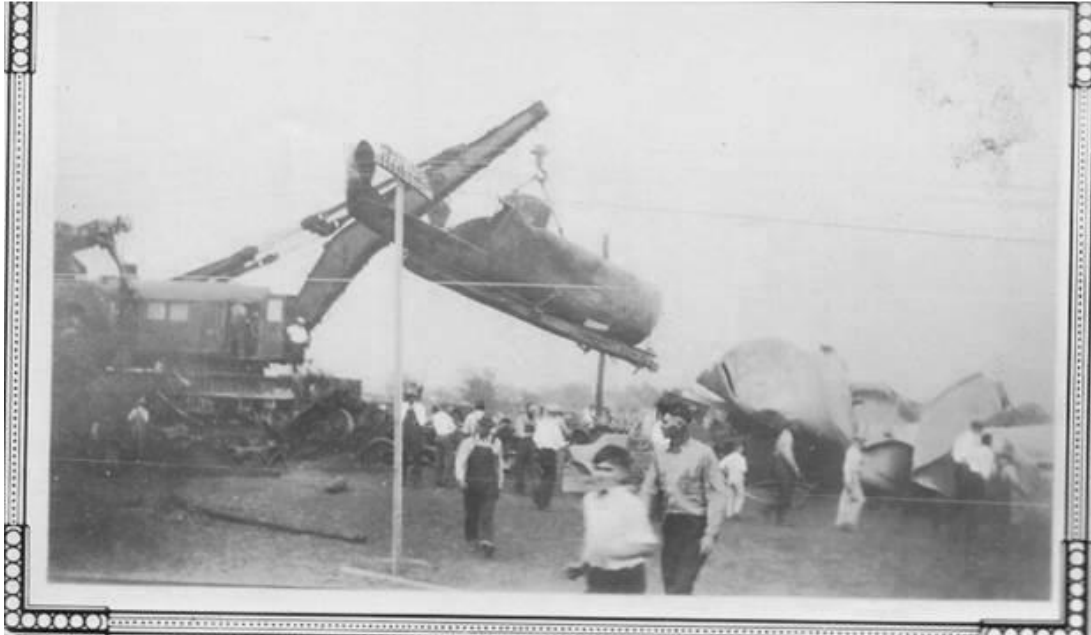
Another photo showing a railroad crane removing destroyed tank cars from the 1930 Kremlin train wreck. Note the exploded tank suspended by the crane.

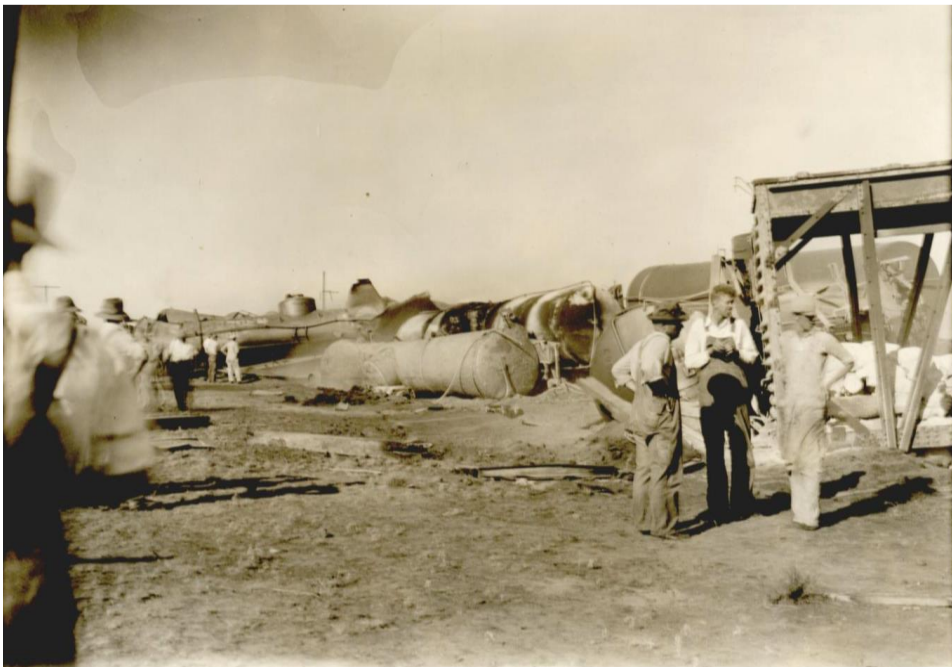
Below: "Rock Island wreck at Kremlin, where 4 men were killed, 18 oil cars destroyed and houses burned." (Earl's Photo Shop; 28 November 1930; OHS Photo Collection)

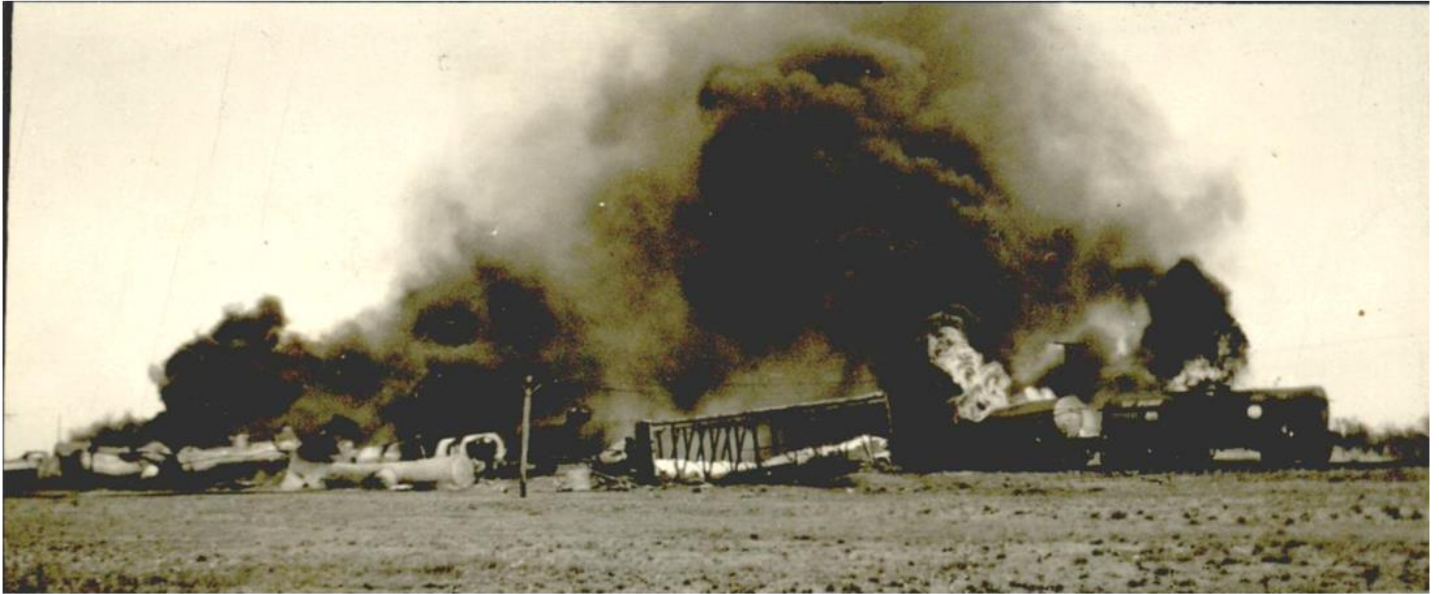
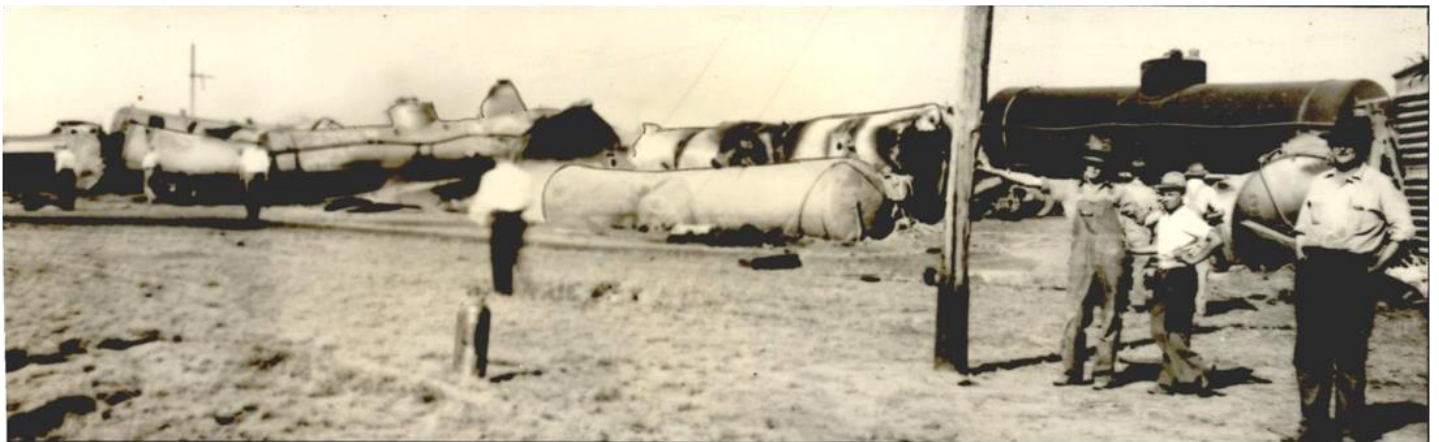
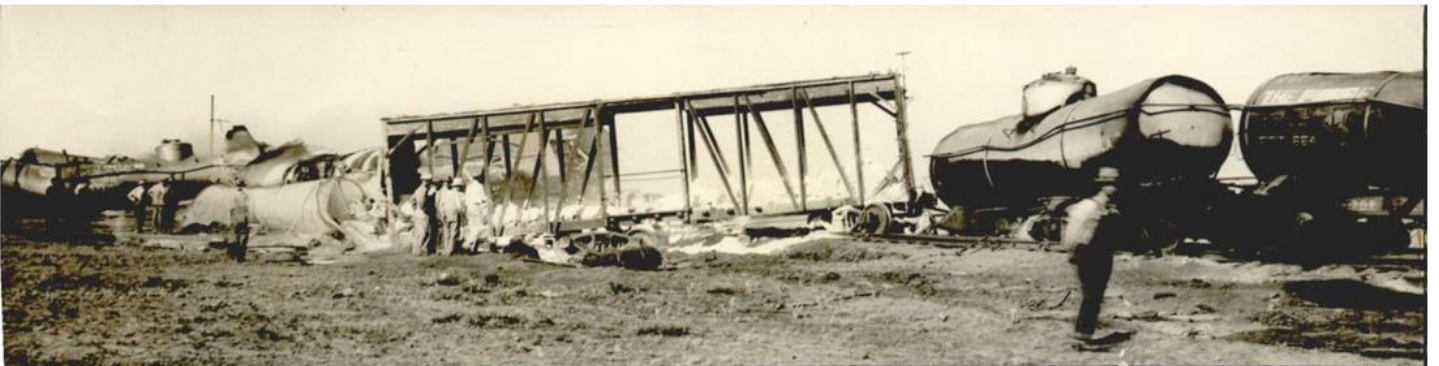
Photos below are from the same [OHS collection](#) as previous page, taken on [14 September 1930](#). Captions for all three read simply "[R.I. near Kremlin.](#)"

[Mary Francis and Paul Hoover](#) remember railroad workers shooting holes in the burning tank cars to help drain them, so they did not explode (1994 Kremlin Centennial Bronc yearbook). [John Richey](#) also recalls one of his uncles using his WW-I Army rifle and armor-piercing ammunition to puncture and help drain burning tank cars as well (personal interview with Myron Toews, 10/2022).

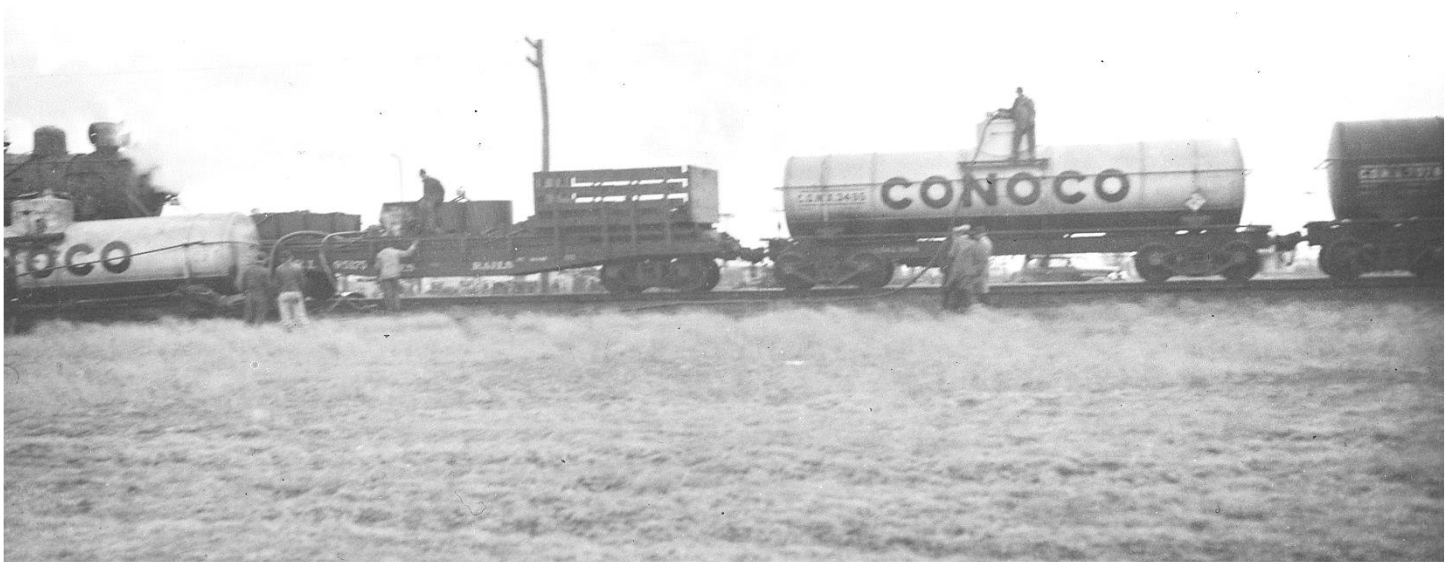
Perhaps the photo below is also from the 1930 wreck (or the June 1950 wreck N of Kremlin, p 33). It appears to show fuel being pumped from a derailed Conoco tank car into another Conoco tank car on the tracks. Note steam locomotive at extreme L and cars and buildings in background. Image from [Toews Family](#) negative digitized by Myron Toews. Probably looking E.

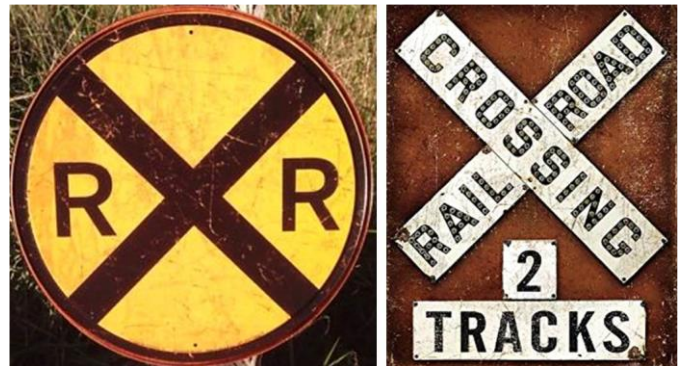
There was a circular yellow railroad crossing sign 500' W of the grade crossing and another white sign 25' W, similar to those shown at R (the second sign nearest the crossing read "1 Track," not "2" as in the photo).

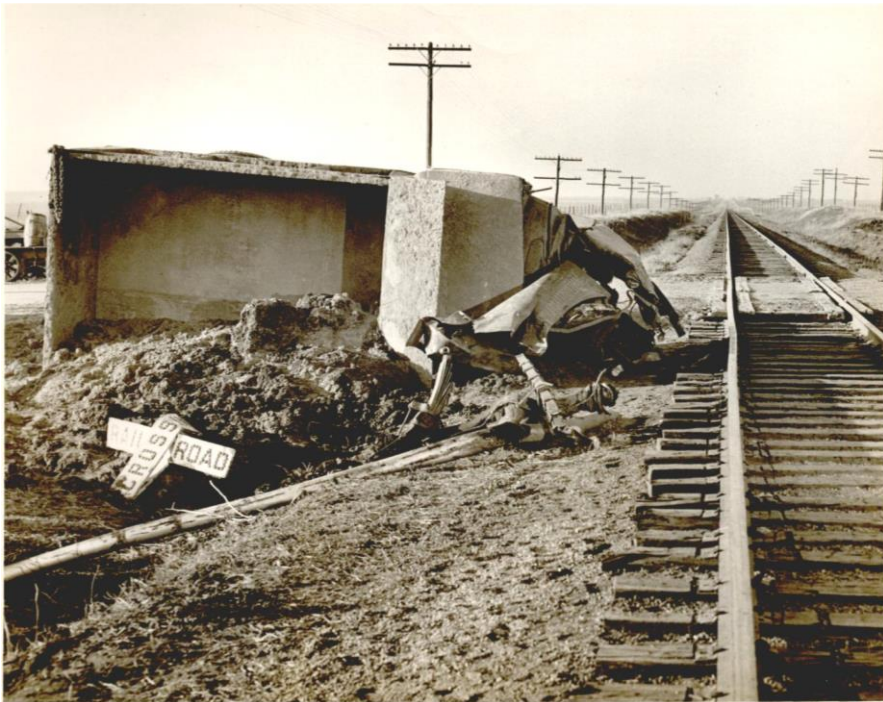
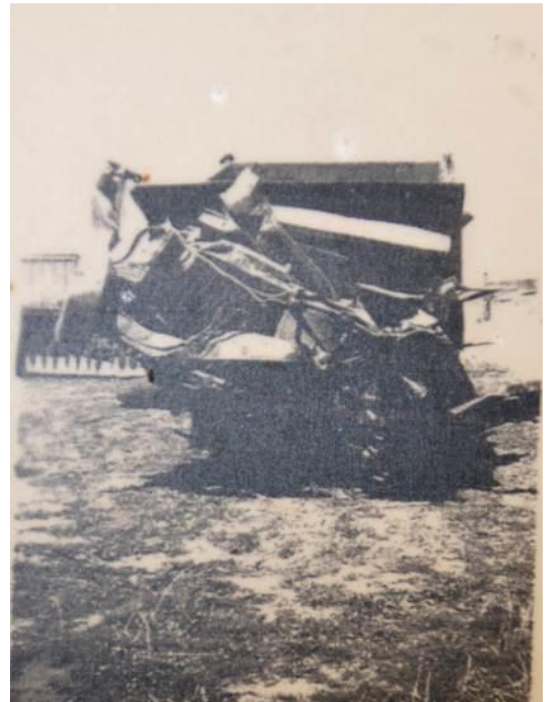
wrecked truck. Looking N towards Pond Creek (elevators barely visible). (Al McLaughlin, OHS Photo Collection; also on cover) R: "Dump Truck That Hit The Train" (FWZ BLDG).

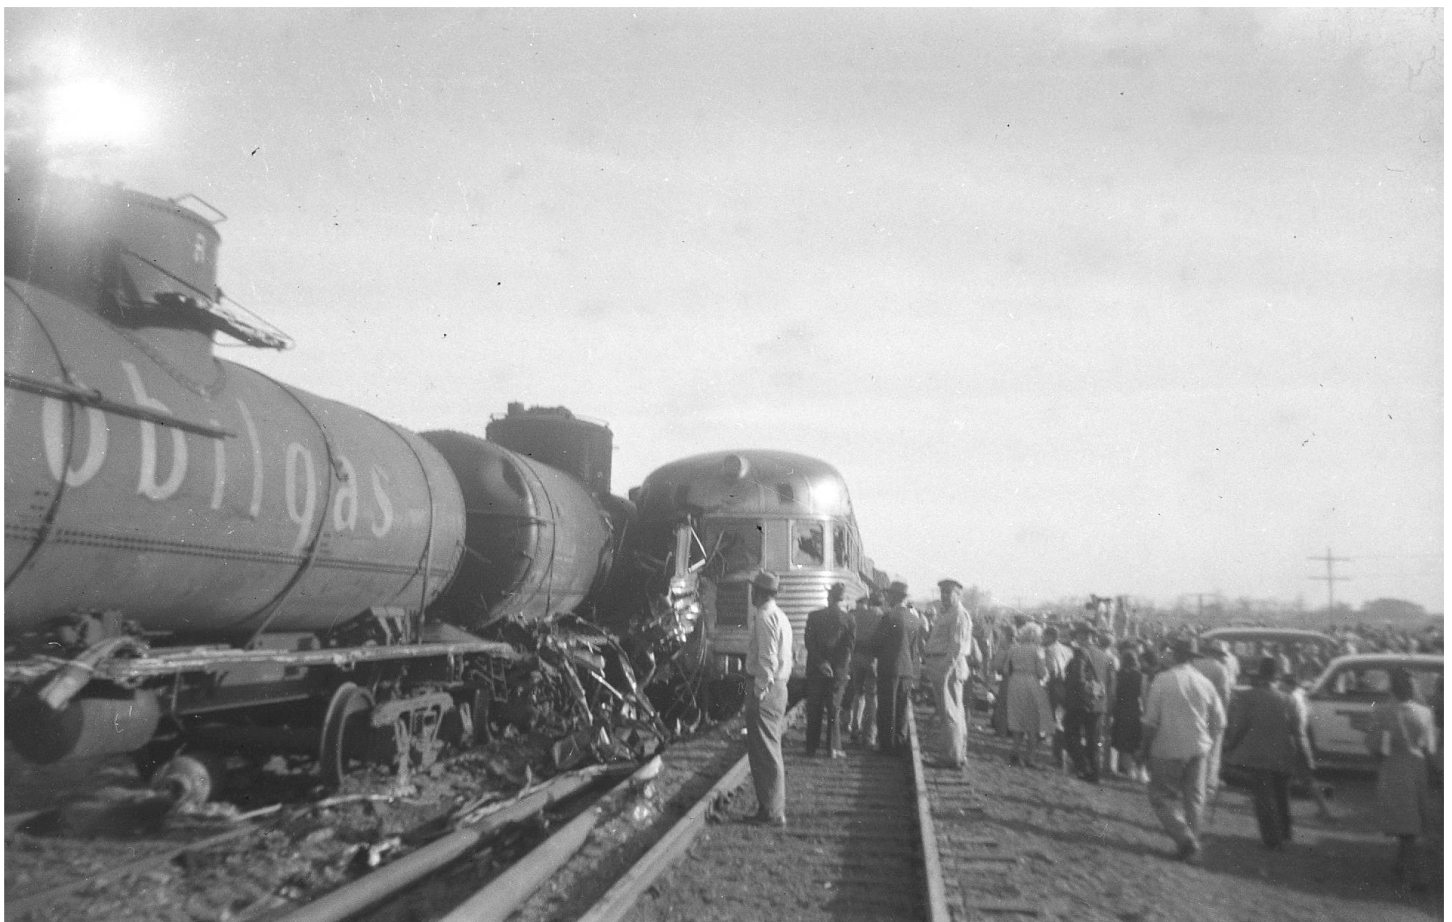
Below: View of coach/parlor/observation car (last car on the train) against tank cars of the freight train in the siding, looking S. Photo taken soon after the accident; note OK Highway Patrol car at extreme R. (TOEWS FAMILY ARCHIVES)

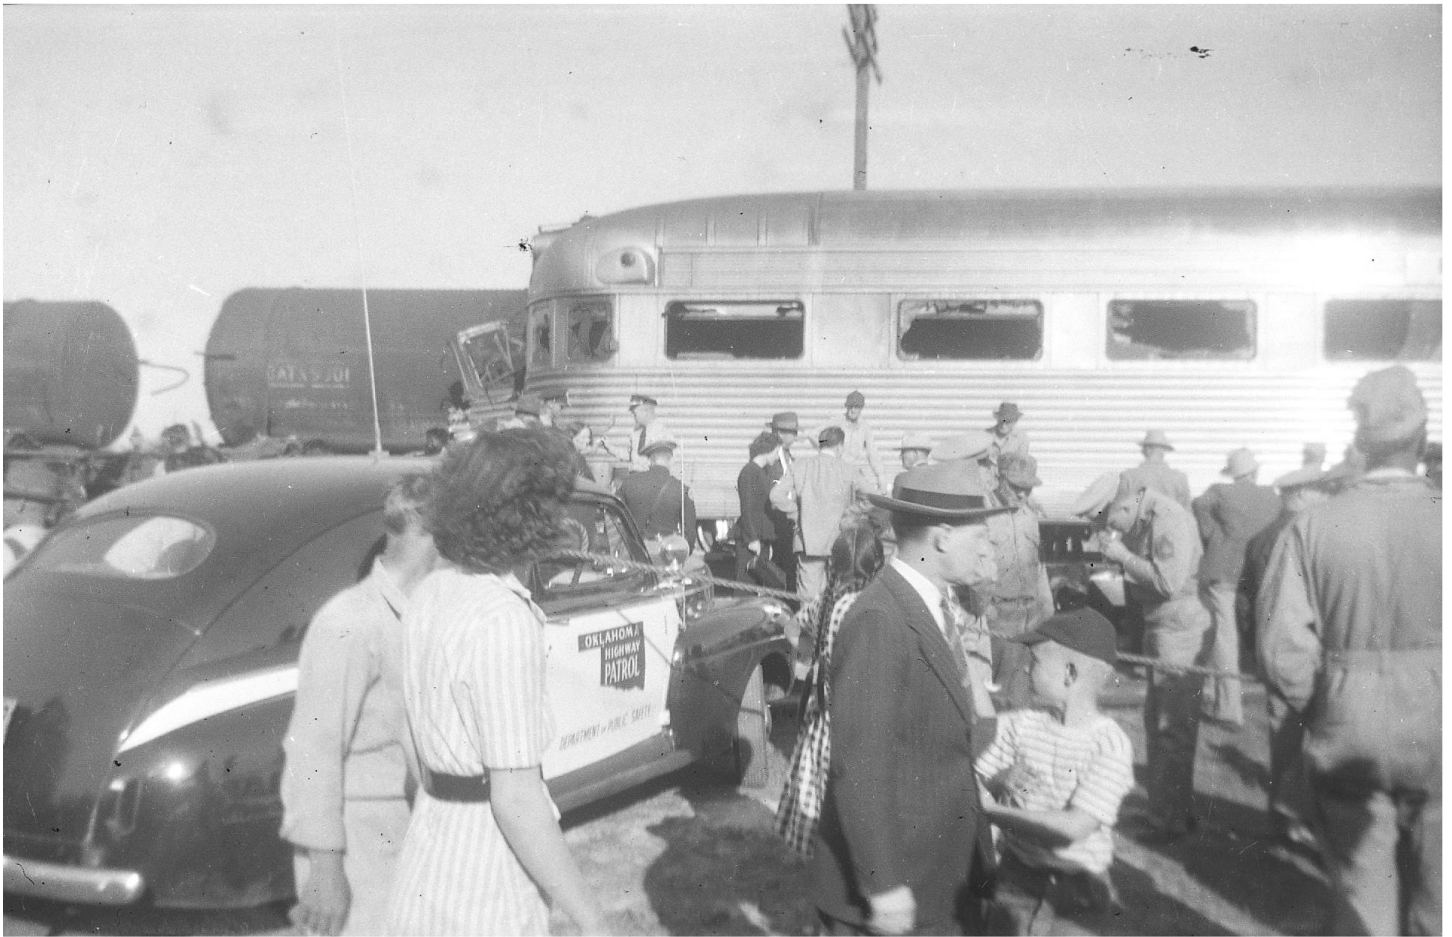
Above: Spectators and OK Highway Patrol car in front of coach/parlor/observation car (last car on the train) against tank cars of the freight train sitting in the siding. Looking E. Photo taken soon after the accident, 14 April 1948. [\(TOEWS FAMILY ARCHIVES\)](#)

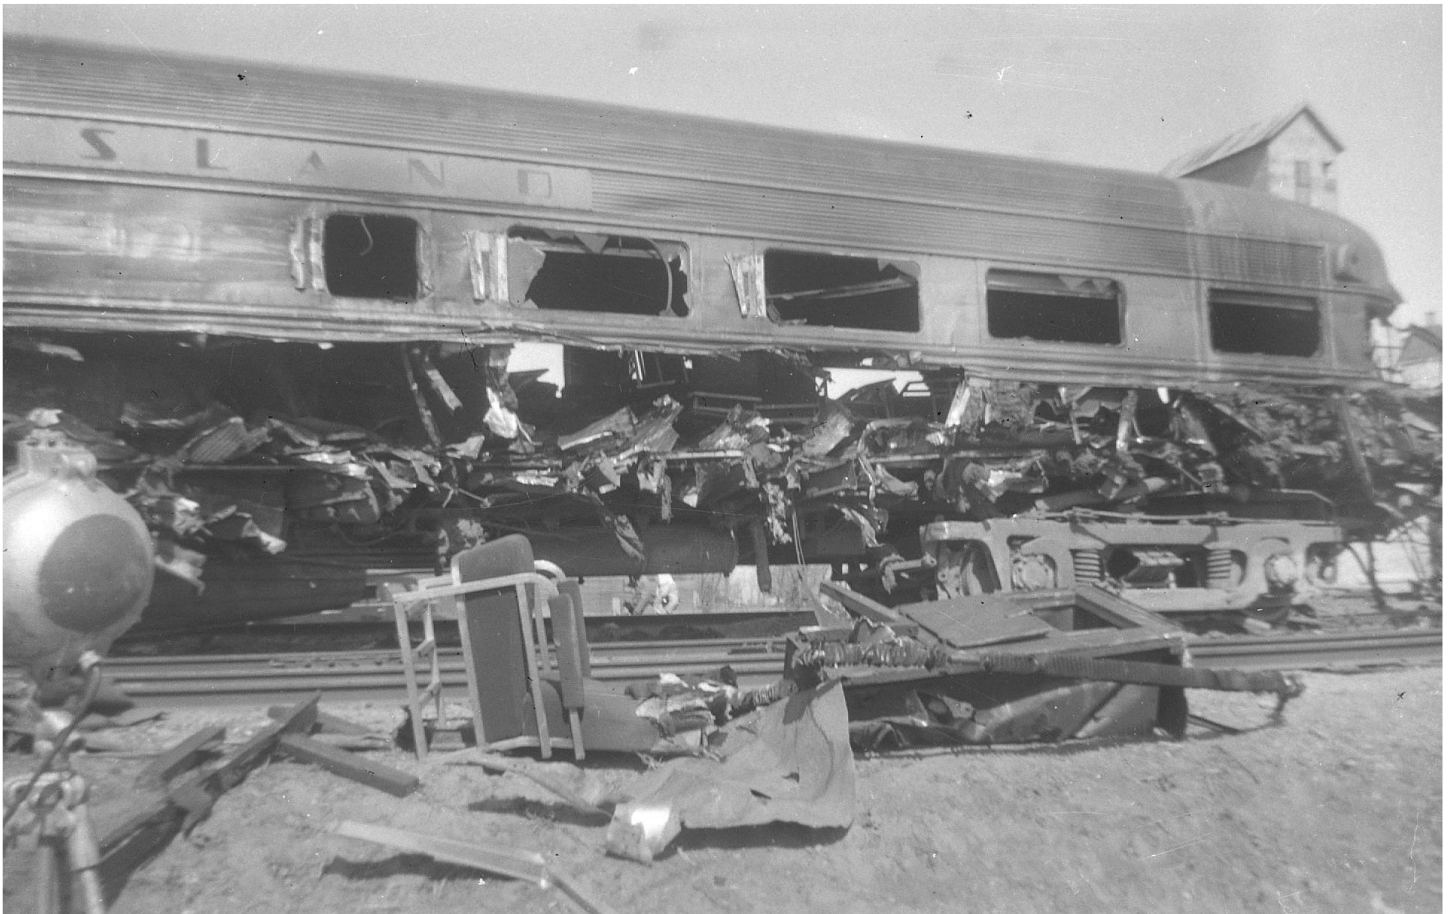
Next page top: Rear of the coach/parlor/observation car (last car on the train) that burned showing damage from being raked against the freight train parked in the siding and subsequent fire. Note the badly mangled and burned interior, seat at foreground, and Zaloudek's wooden elevator at R background. Looking WNW. Cars of the freight train in E siding have already been removed. [\(TOEWS FAMILY ARCHIVES\)](#)

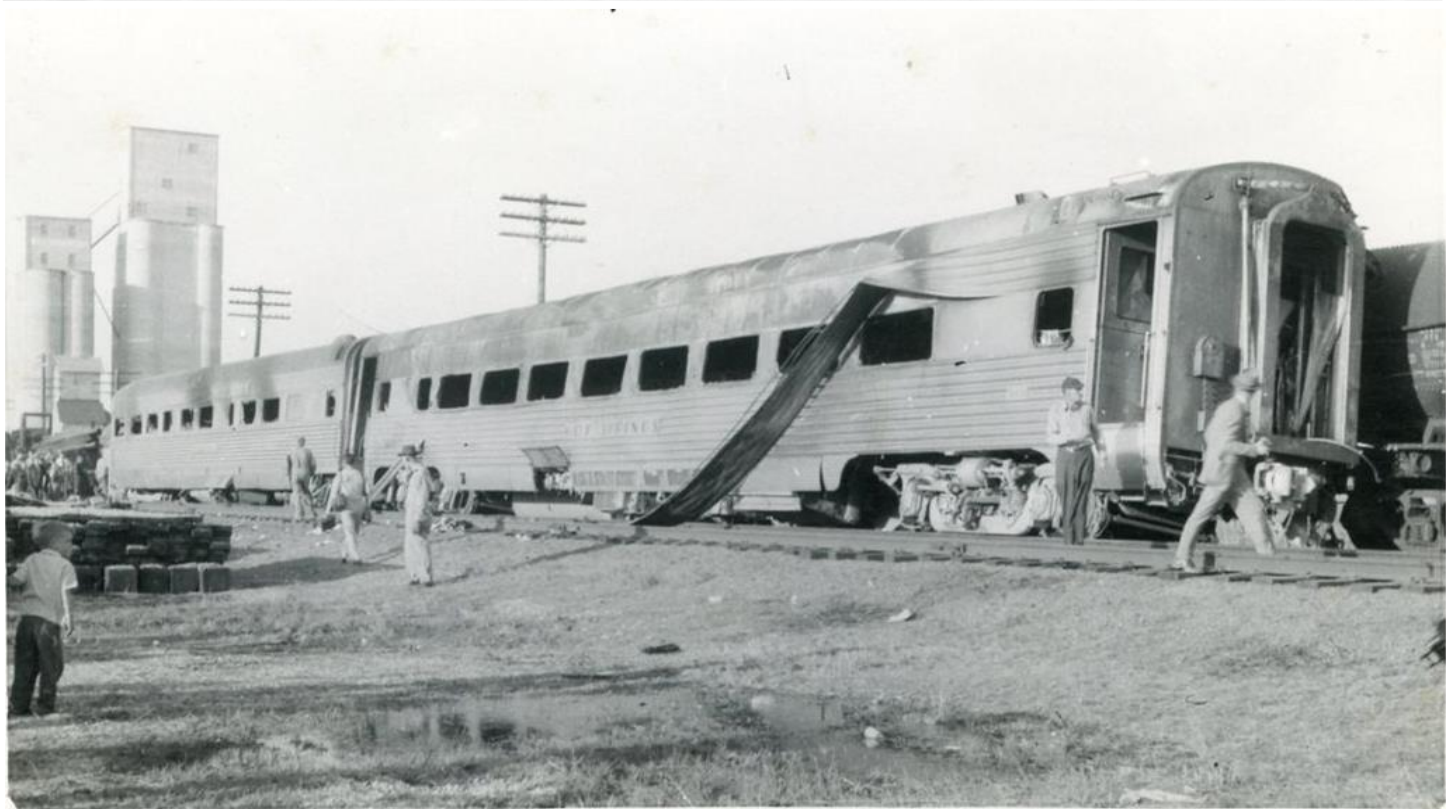
Next page bottom: ["Fire in the Hot Springs rail car in Kremlin Oklahoma"](#) looking NNE from near depot ([from online photo search](#)). Note Farmers Grain Company elevators, including small tin elevator building and the overturned freight caboose in front of the elevators at far L. The front car is the "Hot Springs" coach car (car 4; name visible on side) and the back car is the coach/parlor/observation car (car 5). The open side flaps on both cars may indicate the position of the propane gas cabinets under the cars. Perhaps a propane tank is visible above the seat. The engine and first 3 cars have been uncoupled and removed S along the main track.

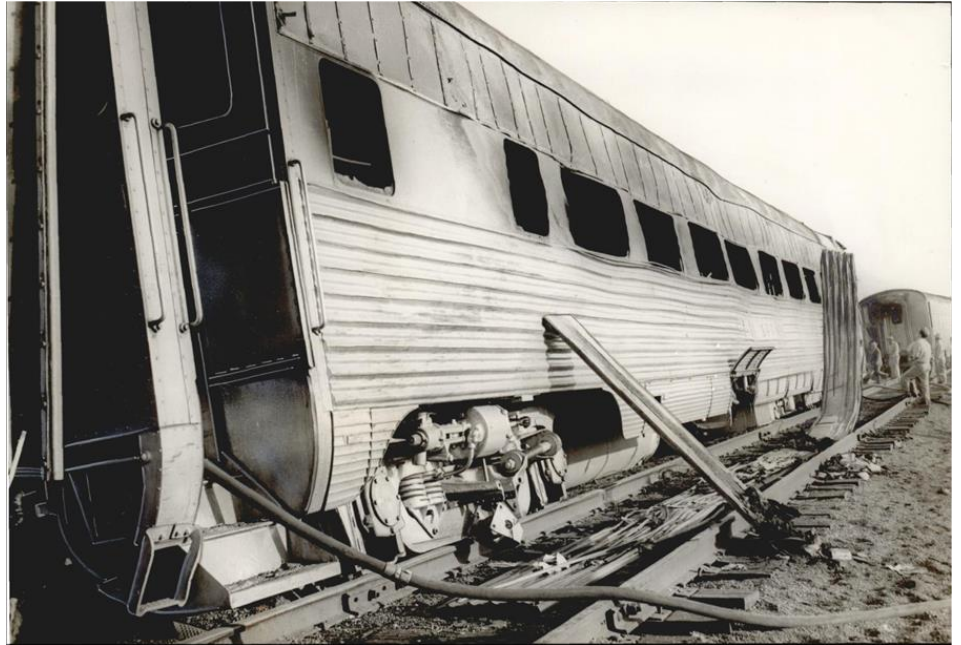
Right: Another view of the [Hot Springs coach car](#), looking S - from the Daily Oklahoman.

Caption reads "A side view of the wrecked and burned coach of the [Rock Island Rocket](#)." Note front cars of the Rocket at extreme R. Al McLaughlin, 14 April 1948
OHS Photo Collection

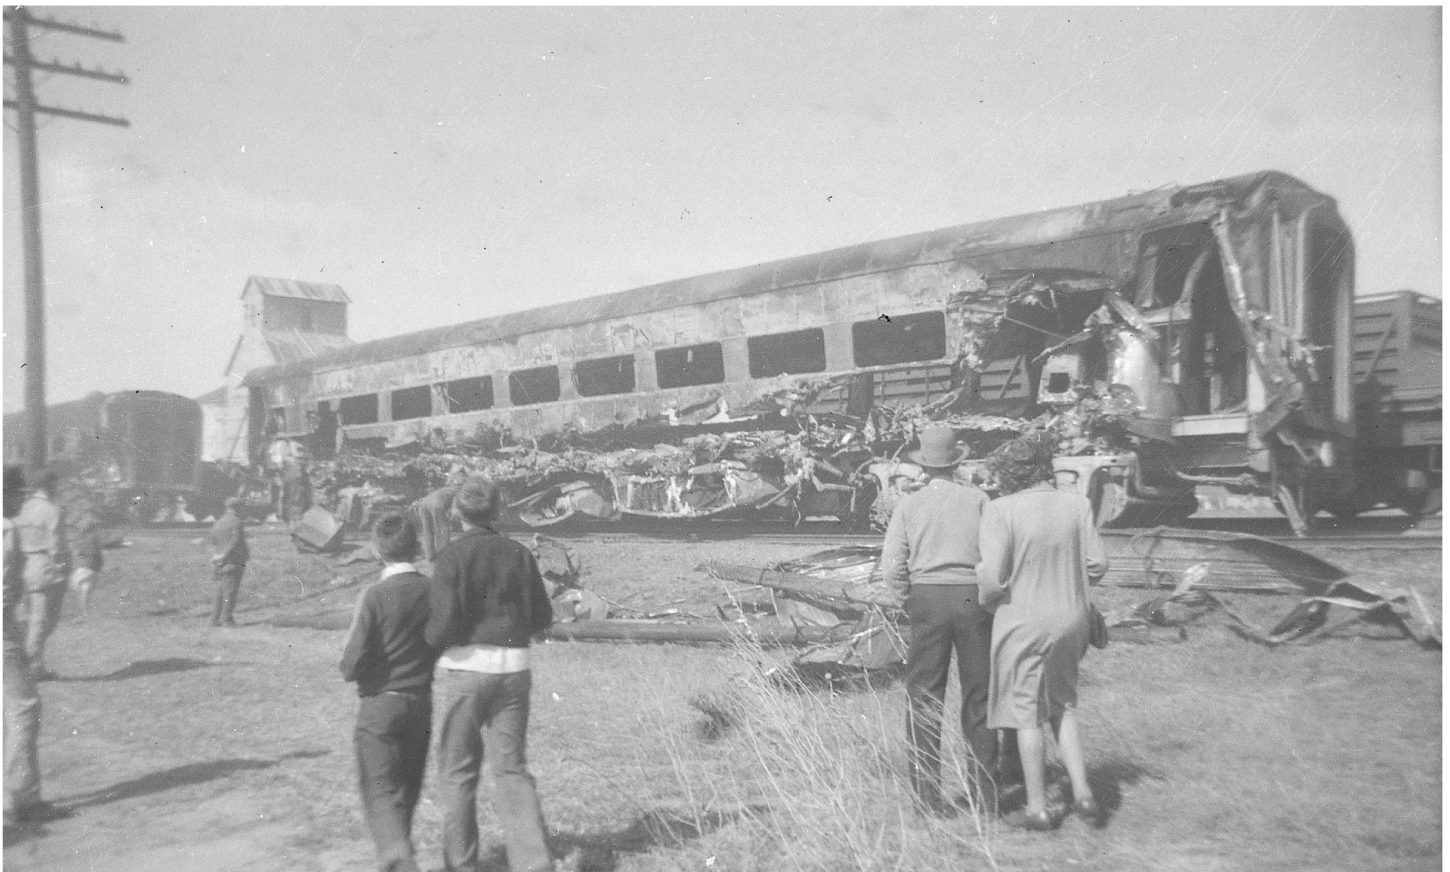
Below: Damaged and burned passenger coach, perhaps car 4, after removal of damaged freight train cars. Note severely damaged left side and vestibule at end of car, and front cars of Rocket on main track. Also note "Zaloudek's" tin/wooden elevator at far L. Looking SW.
([TOEWS FAMILY ARCHIVES](#))

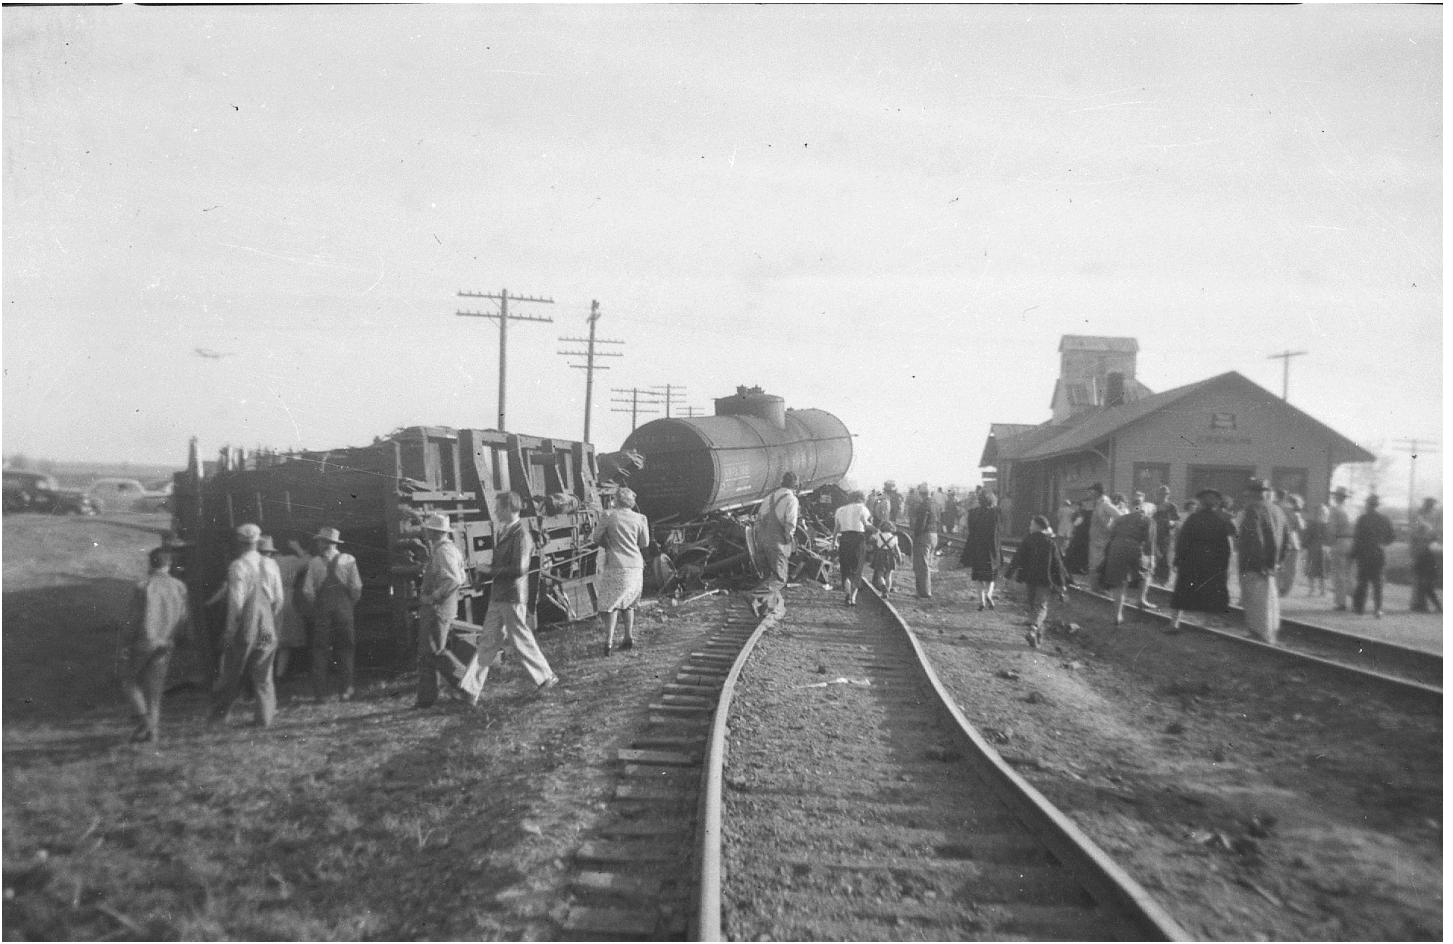
Above: Overtaken caboose and derailed tank car displaced rails of siding track very near Kremlin depot, looking S, after removal of Rocket passenger cars. Note "Zaloudek's" tin/wooden grain elevator behind depot and automobiles at far L. **(TOEWS FAMILY ARCHIVES)**; also on cover

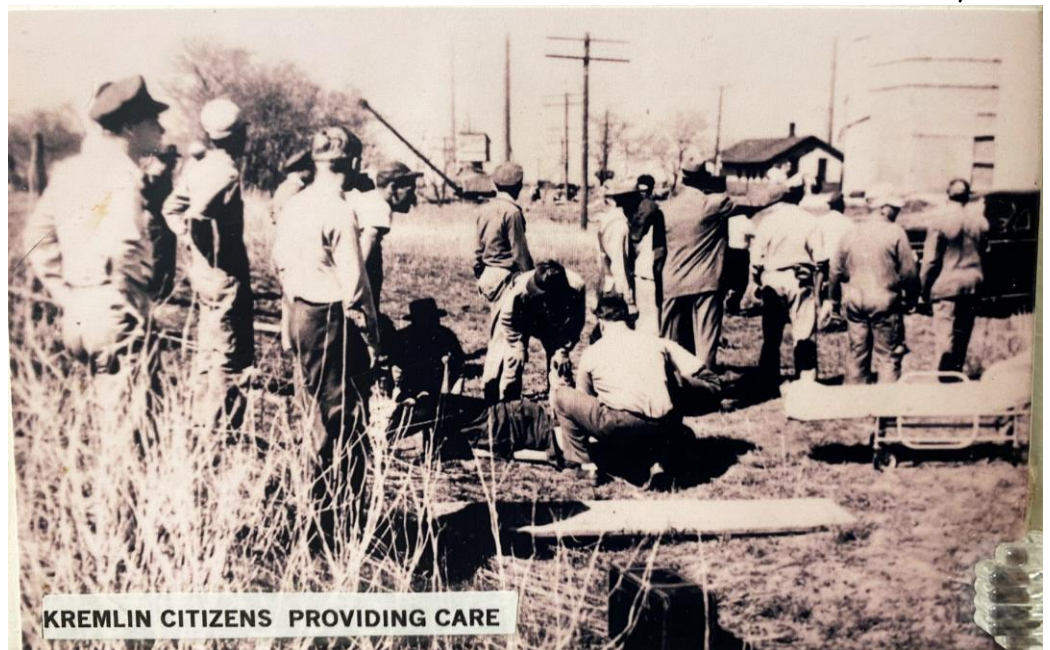
KREMLIN CITIZENS PROVIDING CARE

Below: "Kremlin Citizens Providing Care" (FWZ BLDG). Zaloudek's grain elevator at back center, depot and Zaloudek's tin/wooden elevator office are at R. Note stretchers at lower R, and occupied stretcher at center. Looking NNE.

Note wooden slab in foreground and another behind it on which an injured person rests - these are the "sliding wood doors" mentioned by Mickey Zaloudek on p 29, although he is incorrect in his exact description. They are used to seal boxcar doors.

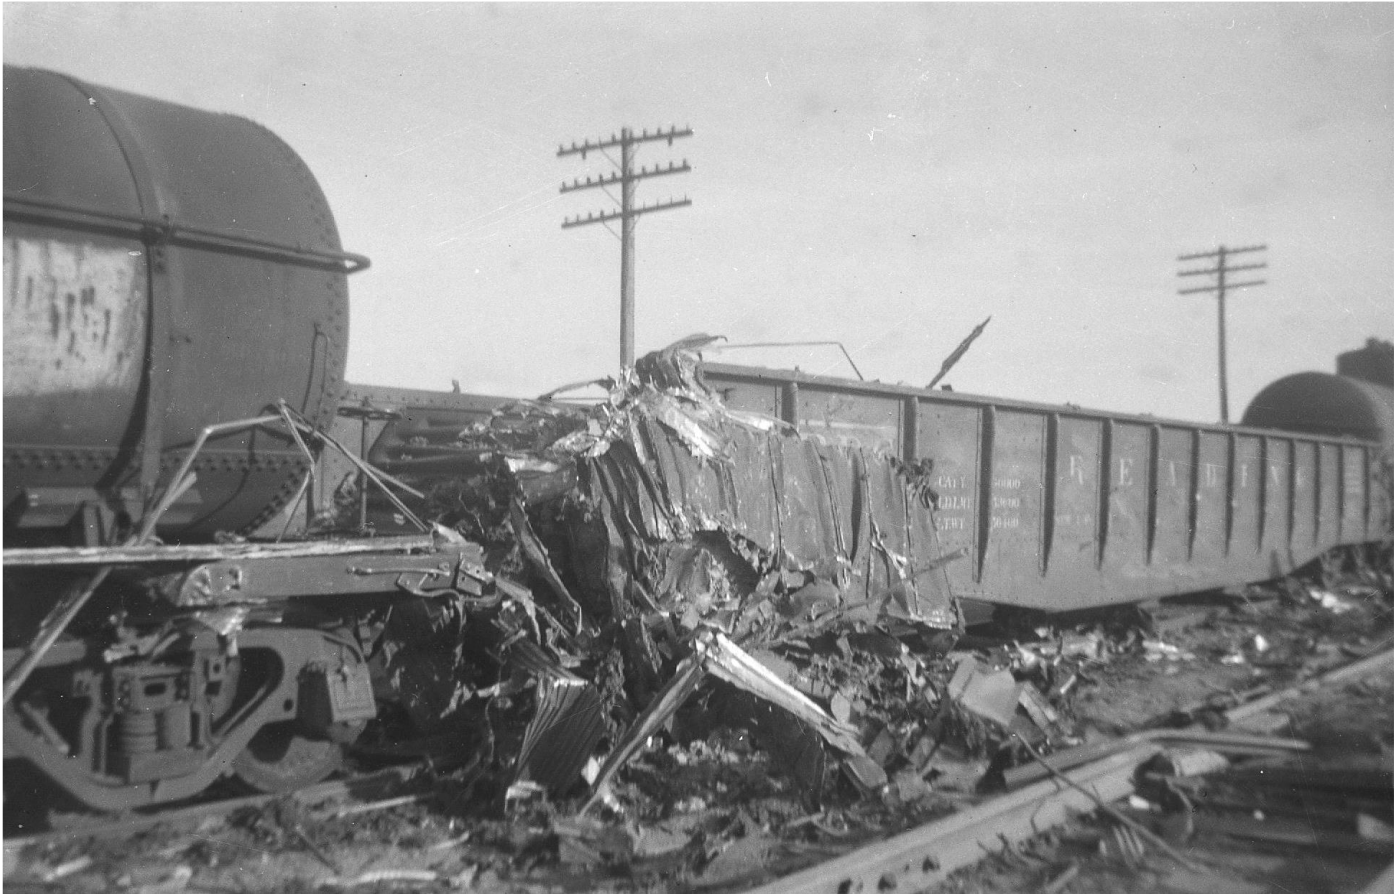
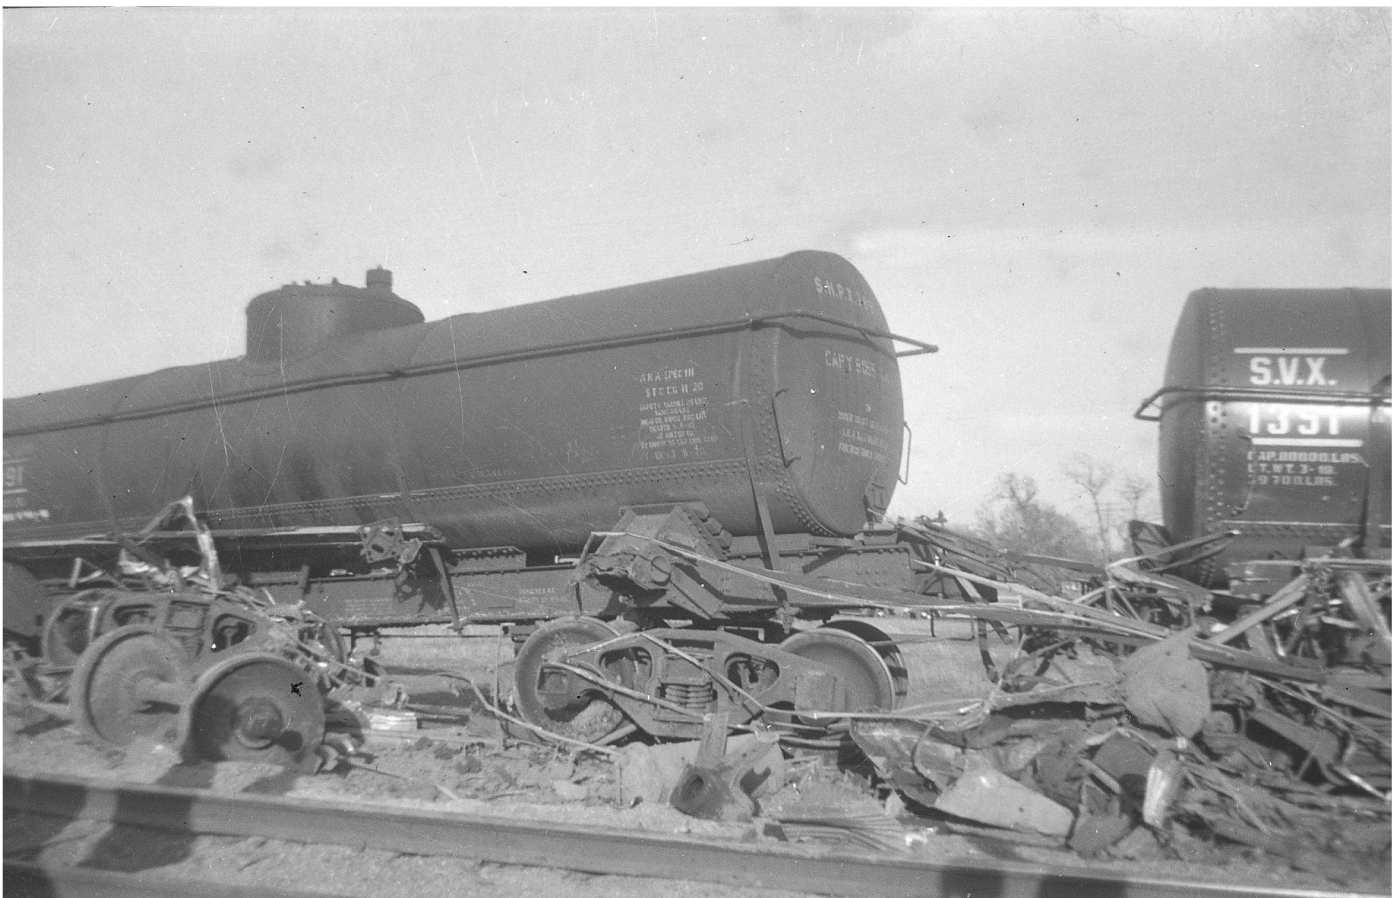
Below, upper & lower: Damaged cars of the freight train in the siding with Texas Rocket debris and ashes beside them, after removal of the Rocket passenger cars. Both looking E.

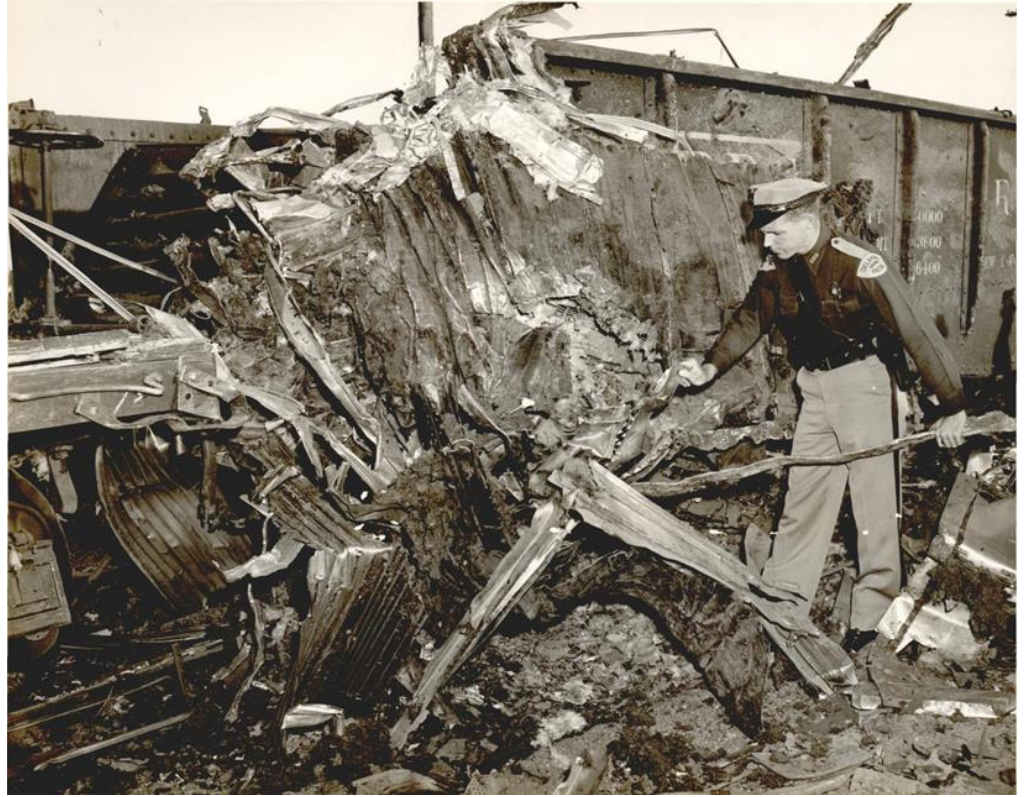
Right: from an Oklahoma Publishing Company newspaper article; caption reads: "**Siding ripped from passenger train hanging on sidetracked freight.**" (Al McLaughlin, 14 April 1948, OHS Photo Collection).

Note the OK Highway Patrol officer examining the debris.
