1948 "Rocket" Train Wreck & Others In & Around Kremlin OK Arrel & Myron Toews

Train Wrecks In and Around Kremlin OK

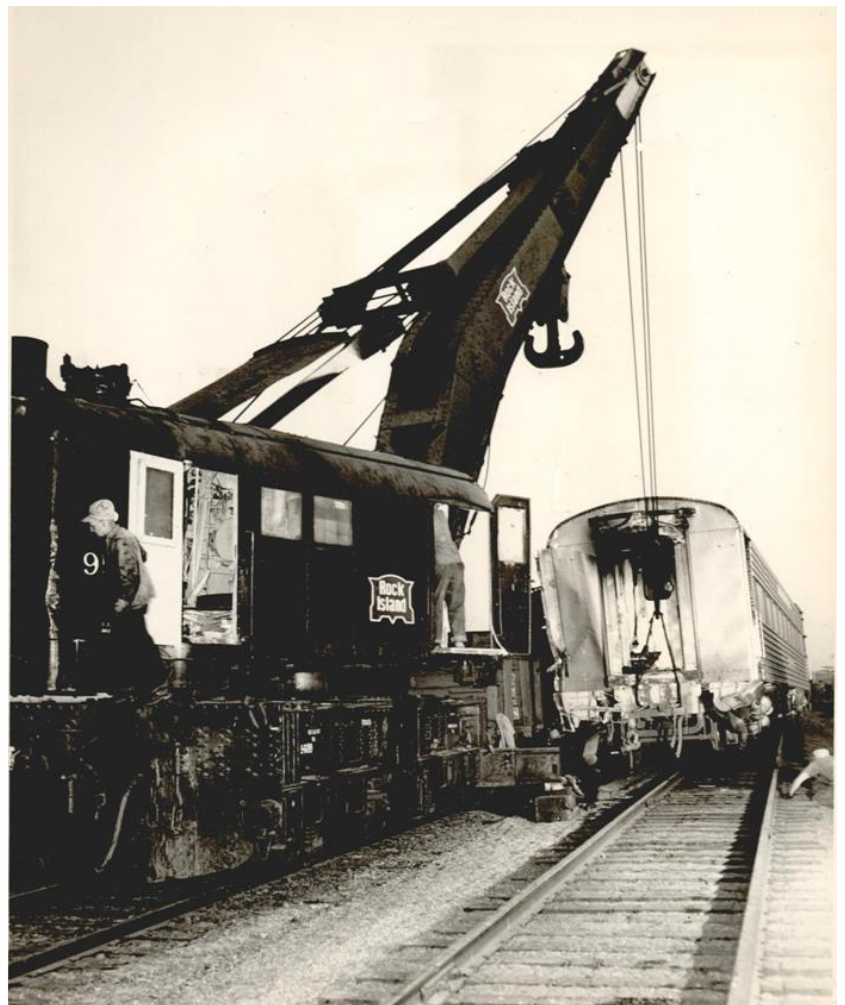
Right: A salvage crane lifts car #3 back onto the main track.
from an Oklahoma Publishing Company newspaper article; caption reads:
"**This was car truck hit. Did not burn.**"
Al McLaughlin, 14 April 1948
OHS Photo Collection

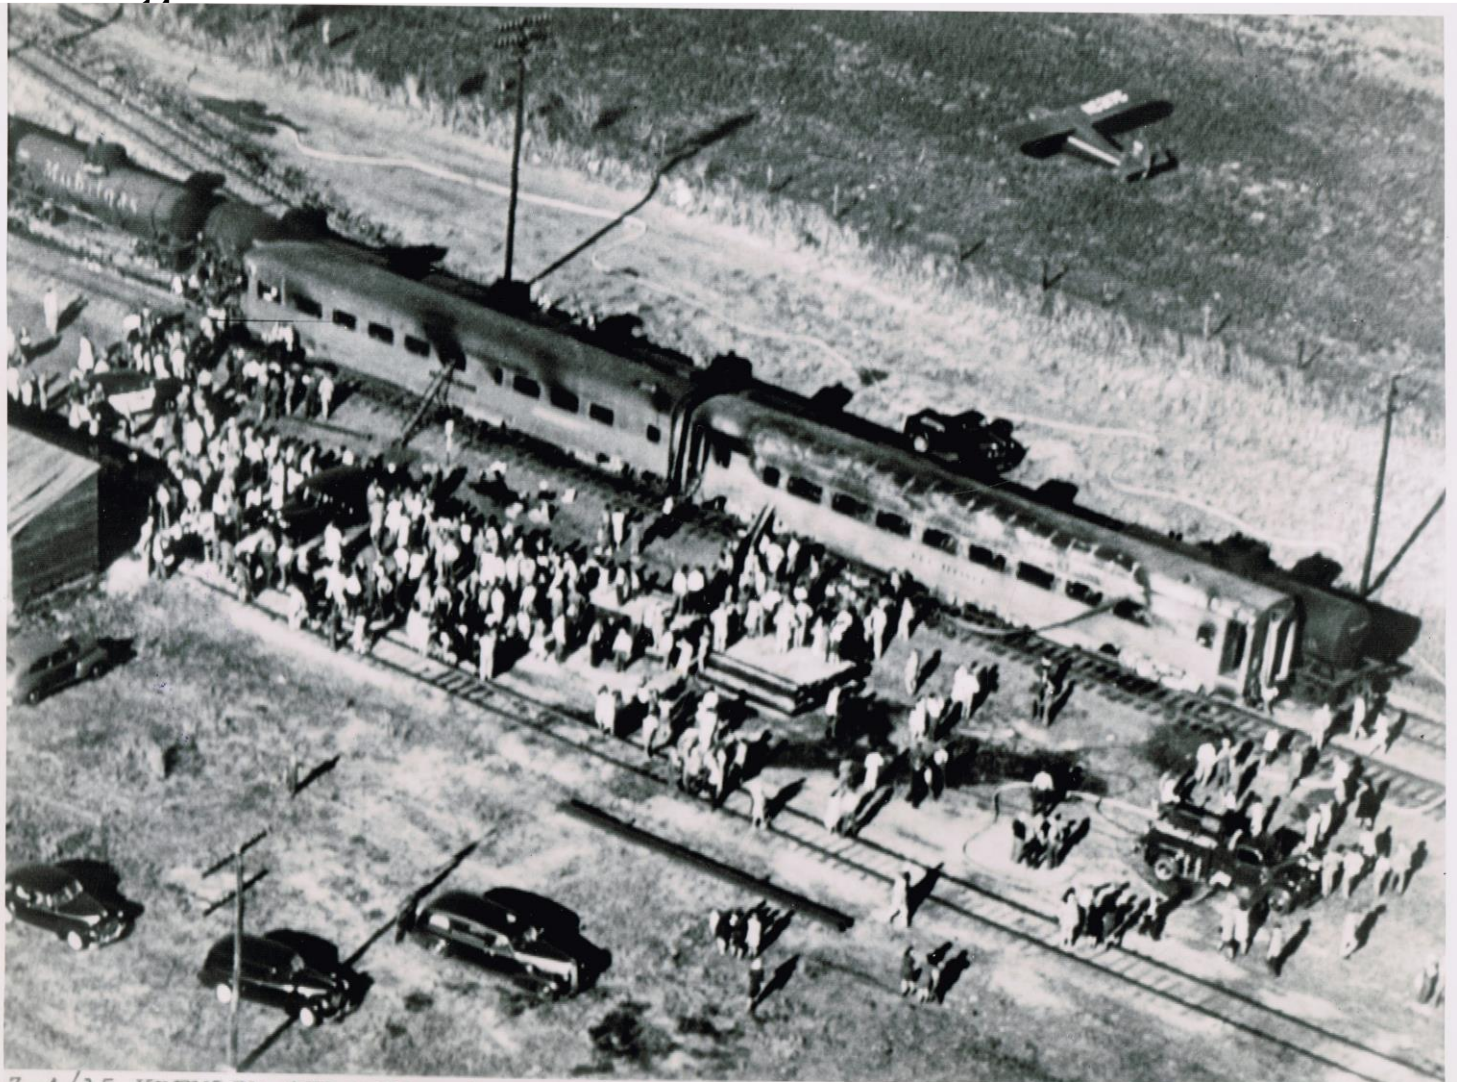
[Aerial photo taken soon after the wreck](#), looking NE (purchased from [HistoricImages.com](#) by Arrel). I believe it was taken from Zaloudek's concrete grain elevator headhouse (looking E) Note airplane and firehoses E of wreck, damaged oil tank cars E of the two Rocket cars (rear parlor car and Hot Springs car), fire truck at lower R with hoses, fire ladder going into last (parlor) car, and ambulances (one among crowd by last car, another in L foreground). The OK Highway Patrol car just W of end of back car is also visible in photos on pages 16 & 17. Extensive fire damage is evident on both Rocket cars; note ladder into burned last car. The stack of railroad ties citizens are standing on W of the R car is also visible in the lower photo

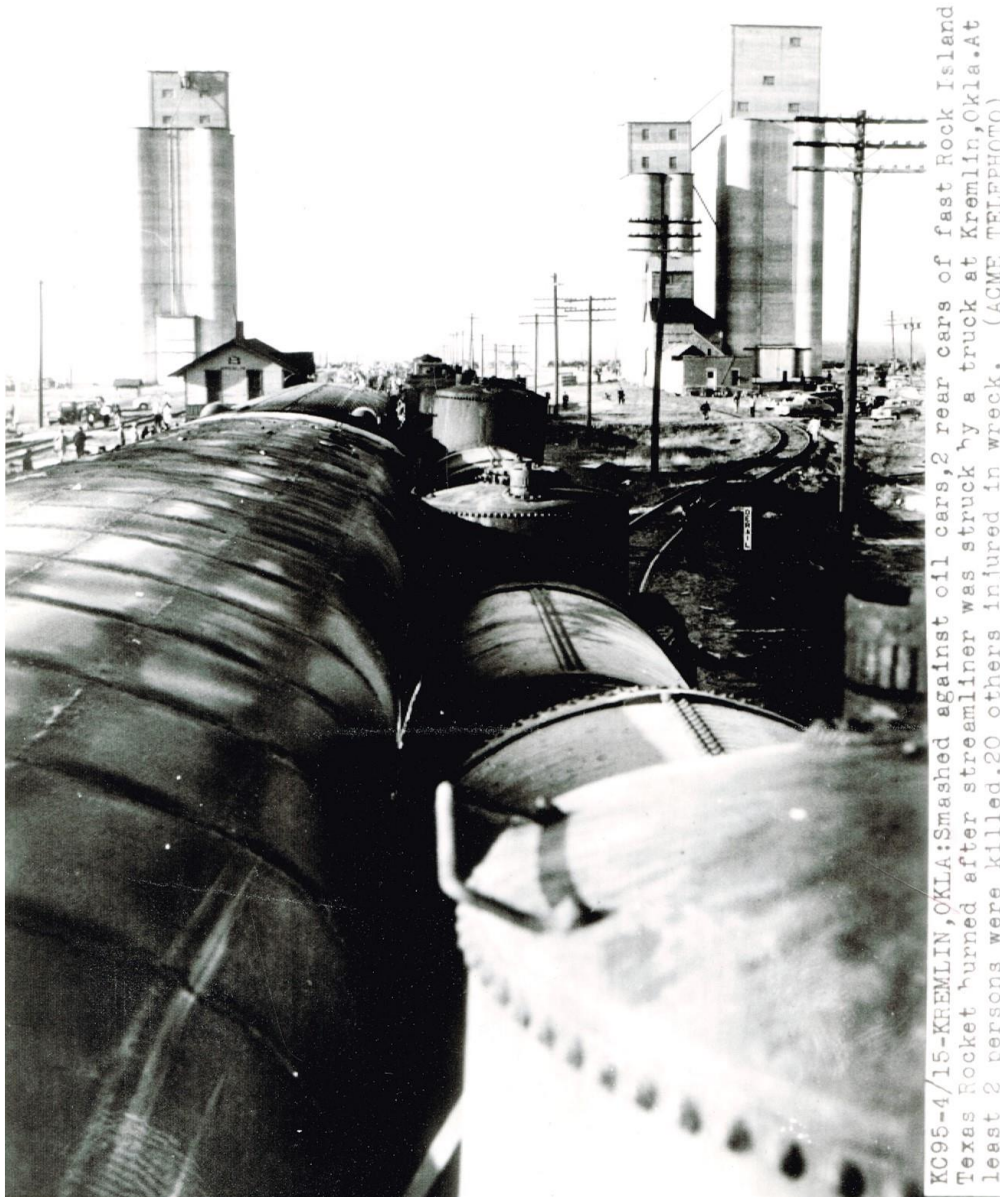
Caption reads: KC95-4/15 - KREMLIN OKLA: Smashed against oil cars, 2 rear cars of fast Rock Island Texas Rocket burned after streamliner was struck by a truck at Kremlin, Okla. At least 2 persons were killed, 20 others injured in the wreck. (ACME TELEPHOTO)

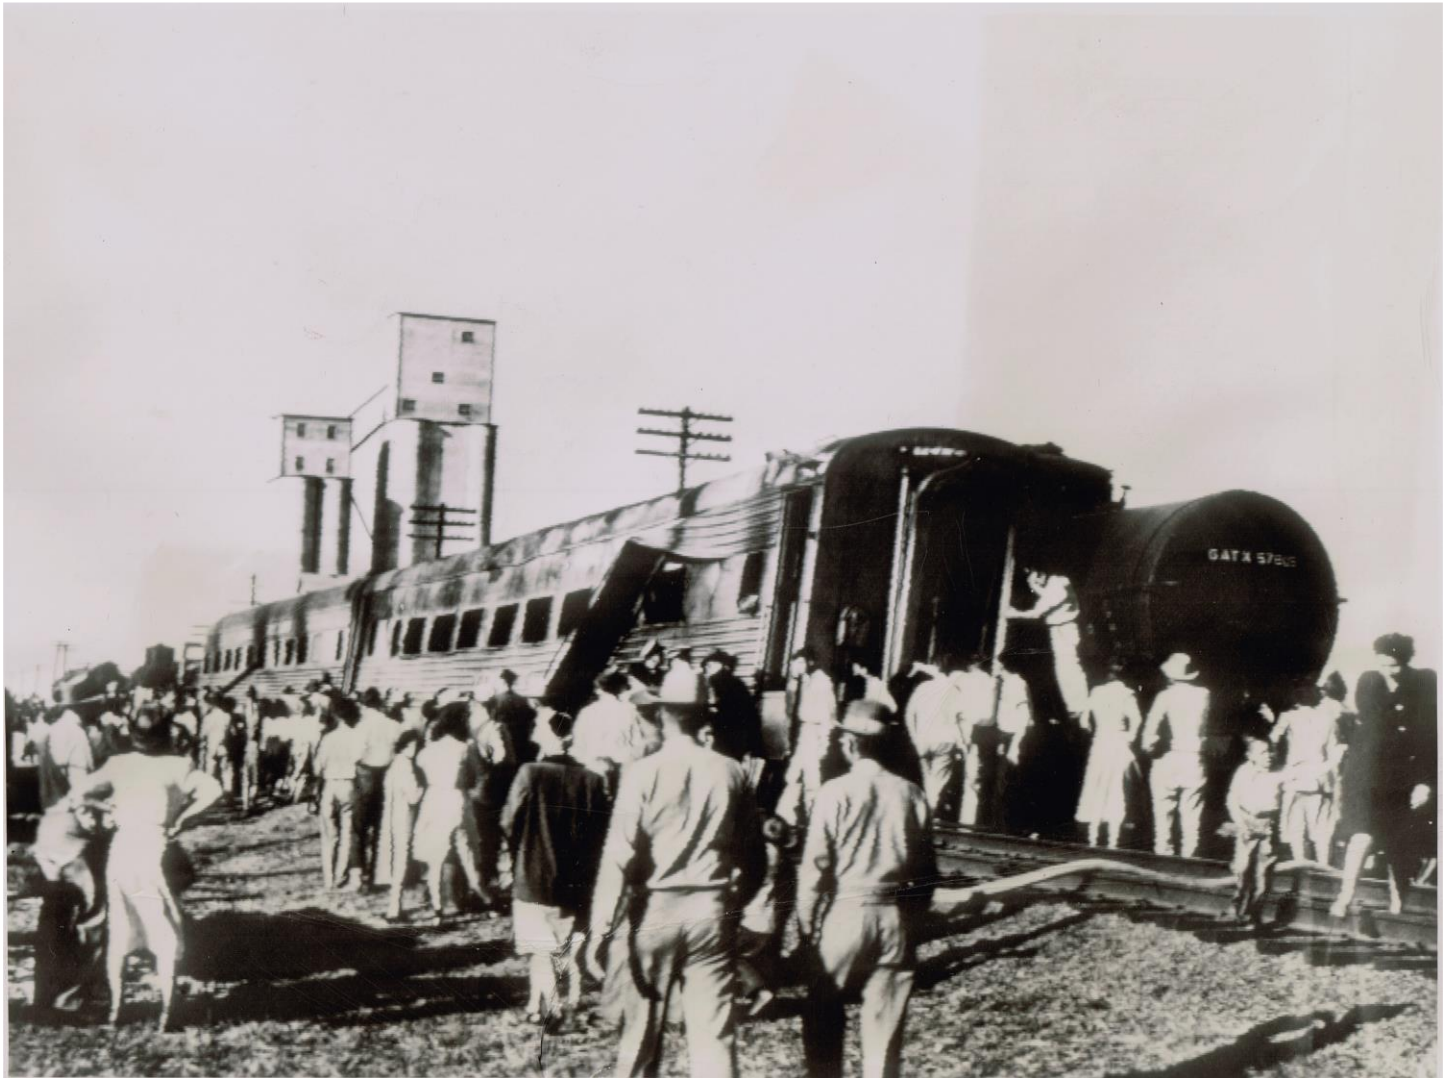
Photo below looking NNE shows last 2 Rocket cars with spectators, Farmers Grain elevators, and tank car in the siding. Purchased from [HistoricImages.com](https://www.historicimages.com). Caption from back is below.

KREMLIN, OKIA: General view of the wreckage of the Rock Island Rocket bound from Kansas City to Dallas, Texas. The train was derailed near Kremlin after it hit a truck. Four persons were killed and 14 injured when two coaches overturned and burst into flames.
CREDIT (ACME TELEPHOTO) 4/14/48 jpd

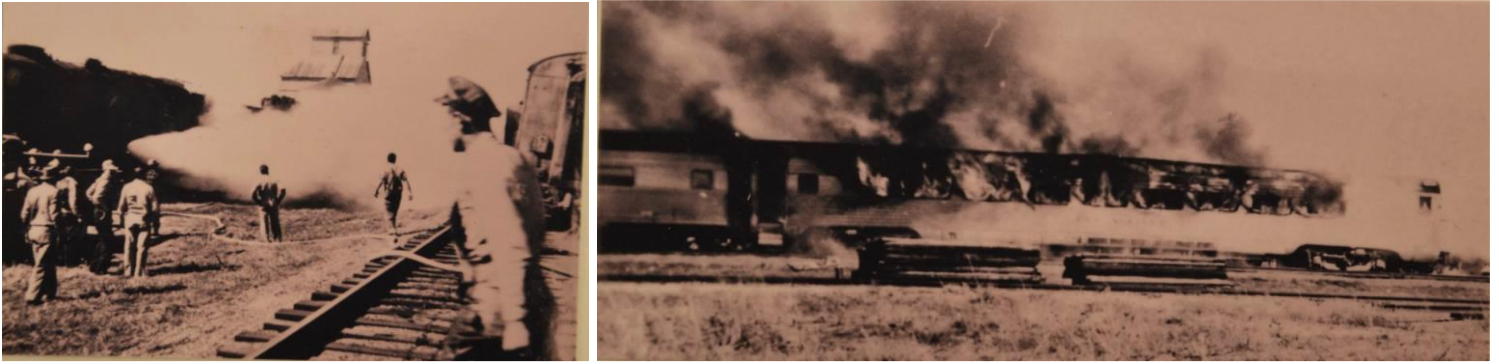
Above (L) "Steam Engine Fighting Fire"; (R) "Burning Passenger Rail Car" (both **FWZ BLDG**). The burning car at upper R is named "Hot Springs" (see also photos on previous pages) but tank cars on siding behind it are not visible, presumably because of the smoke and fire. The front portion of the Rocket has been uncoupled and moved S along the main track. Perhaps a bit of a railcar on the siding is visible at extreme R. This photo is looking ESE from W and just N of the depot. Stacks of railroad ties in front of the car are also visible in lower photo on page 14.

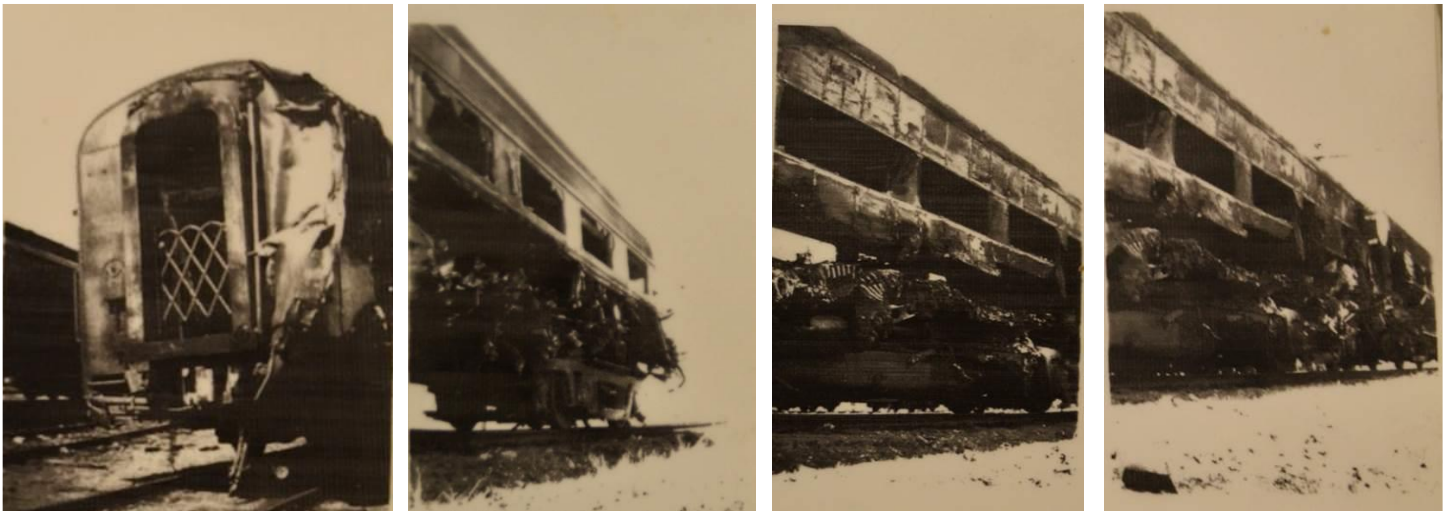
The [block of four photos](#) below are also from that 1948 Kremlin Rocket wreck - they are all from the **FWZ BLDG**. They must be photos of the left sides of the 4th and 5th cars after the freight train and associated debris had been removed and the cars placed back on the tracks. The right sides of cars 4 and 5 were not damaged by scraping in the collision (see photos on previous pages), but the left sides were heavily damaged.

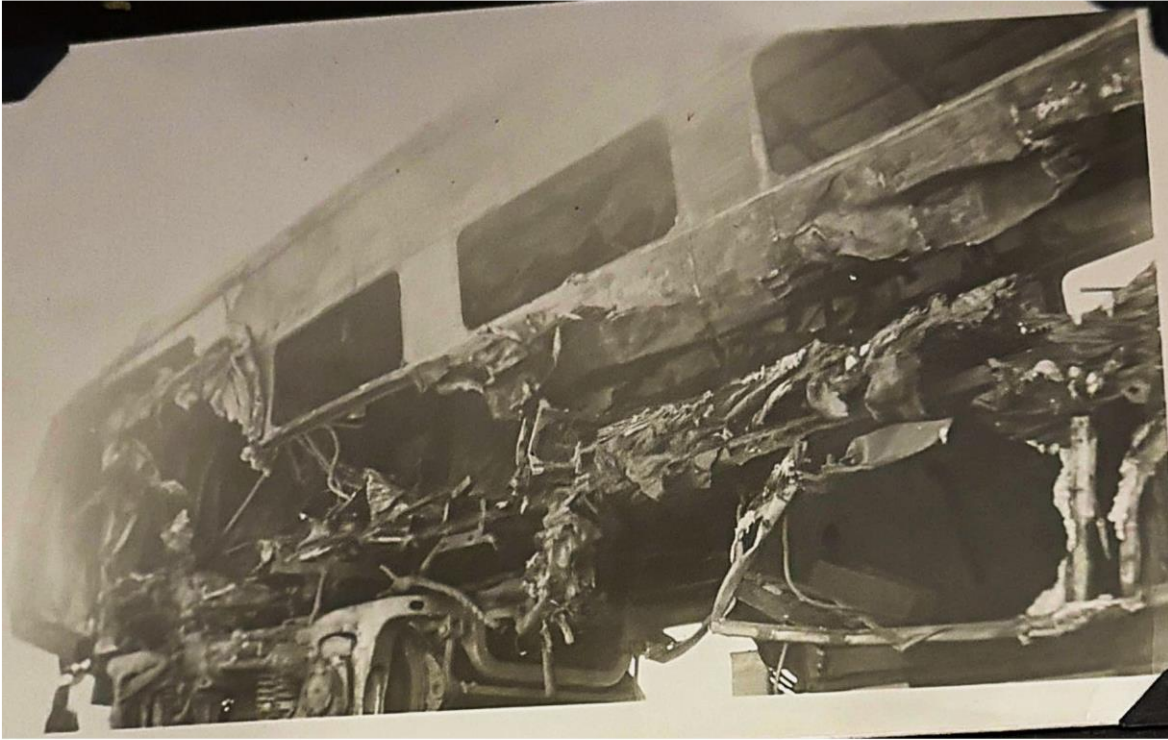
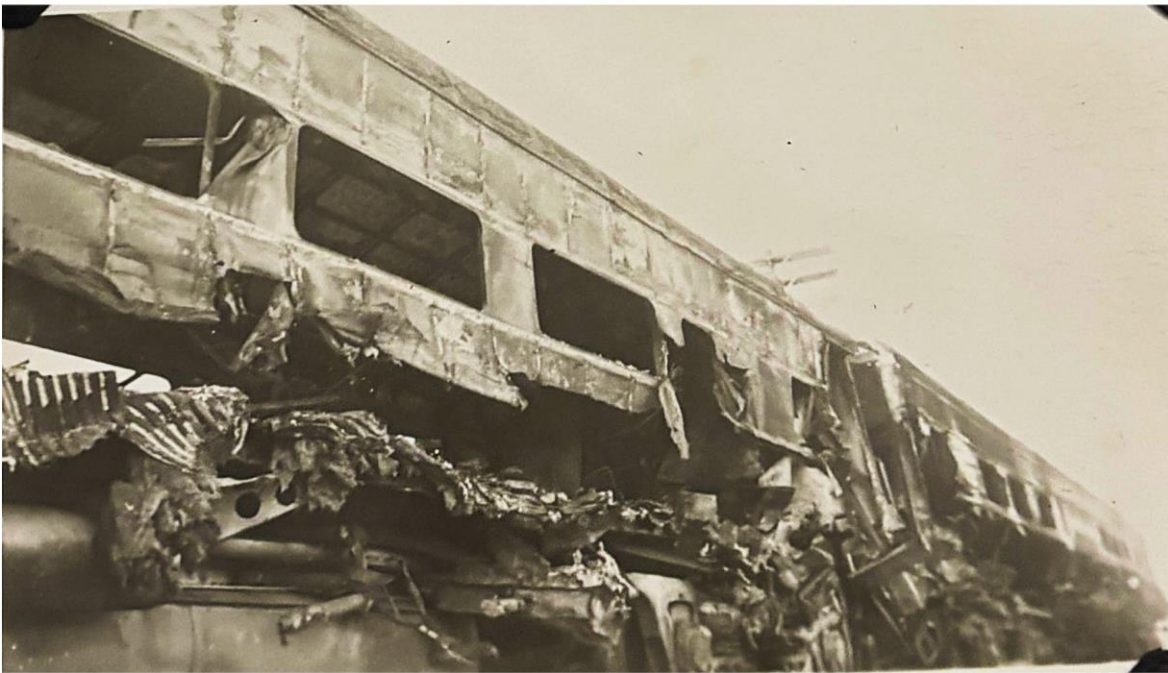
The photos below show close-up damage of the badly mangled and burned last 2 cars of the Rocket. Views are of the left (E) side of the cars. Photos are from a [Fred and Marjorie Randolph](#) family photo album kindly provided by [Betty Randolph Strickland](#). Betty was a classmate of mine for all 12 years at Kremlin Schools and is still a dear friend. Her father Fred was a community leader, including stints on the Kremlin School Board.

Upper photo shows derailed tank cars after the Rocket cars have been cleared. Perhaps the derailed and overturned caboose of the freight train (see p 20) is at L behind the tank cars.

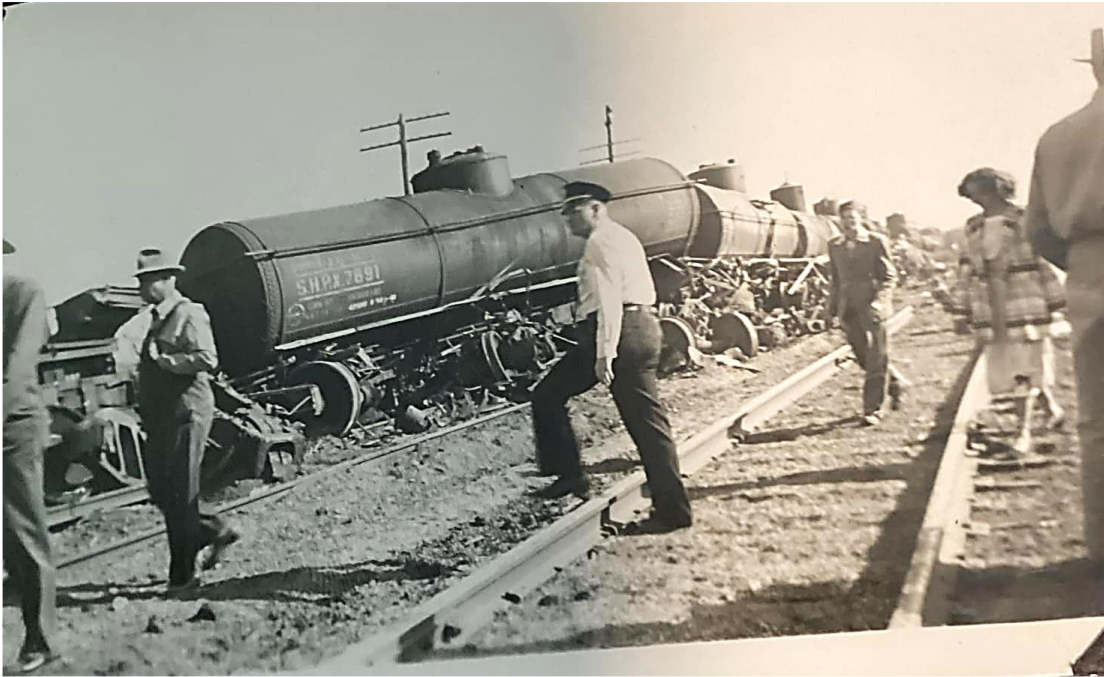
I believe the poorly focused photo below shows the derailed and overturned caboose of the freight train (again, see p 20), now loaded onto a freight train for salvage. Looking N. Zaloudek's tin/wooden elevator and concrete silo elevator are visible at extreme R.

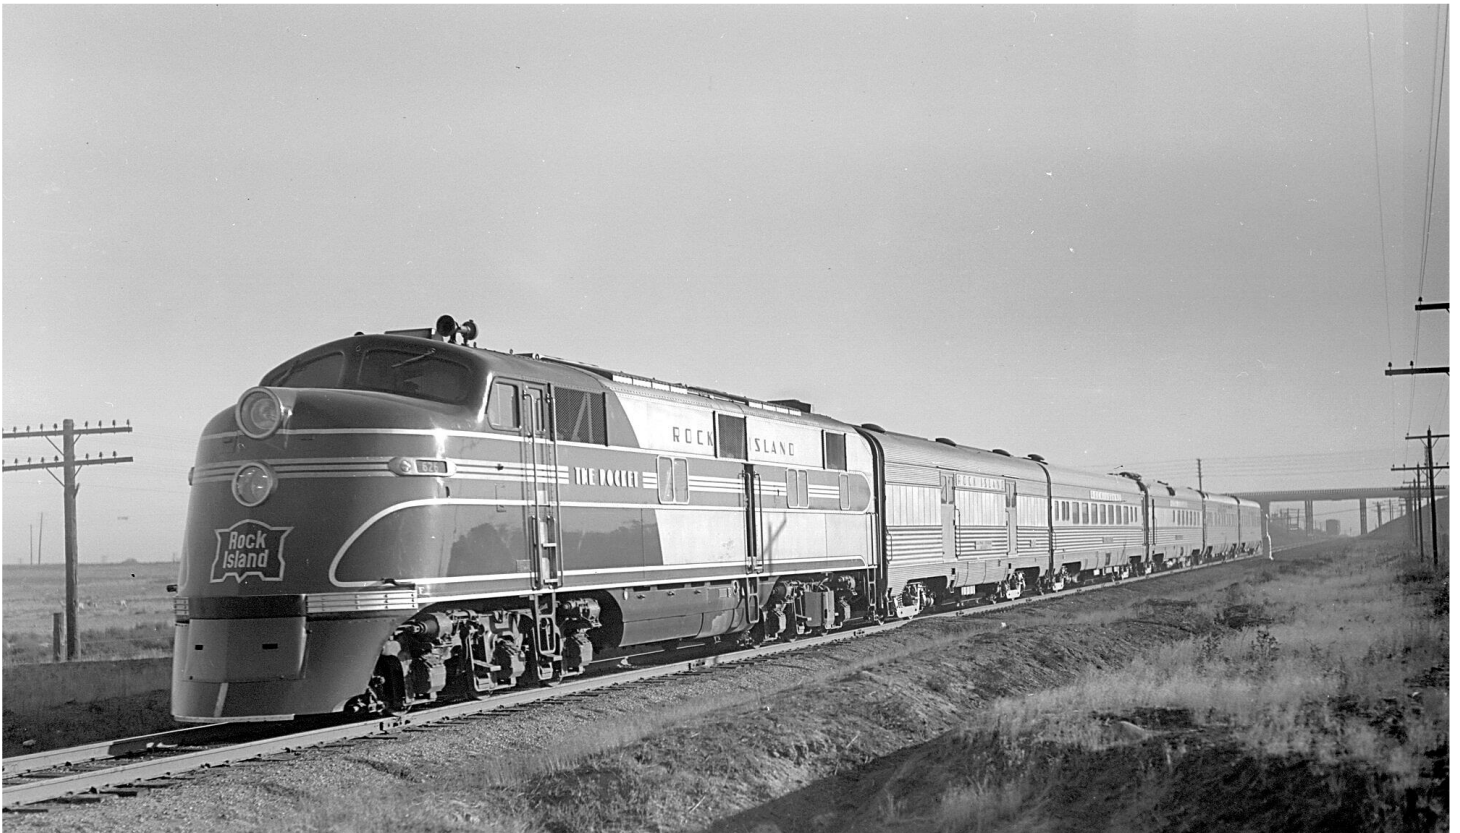
We have no photos of the intact Rocket train that wrecked, nor even views of the engine in any of the many wreck photos, so additional photos and information are shown below. The [photo below](#) is not the exact Rocket that wrecked in Kremlin in 1948, but it is the [same # 626 locomotive](#) and virtually identical configuration of the train that wrecked. So this is what the Texas Rocket train looked like just prior to the collision. Note the 5 cars behind the locomotive - baggage/mail car, dining car, 2 coach passenger cars, final coach/observation/parlor car. This photo was taken on 23 November 1939 near Denver CO (Rocky Mountain Rocket; Train 7).

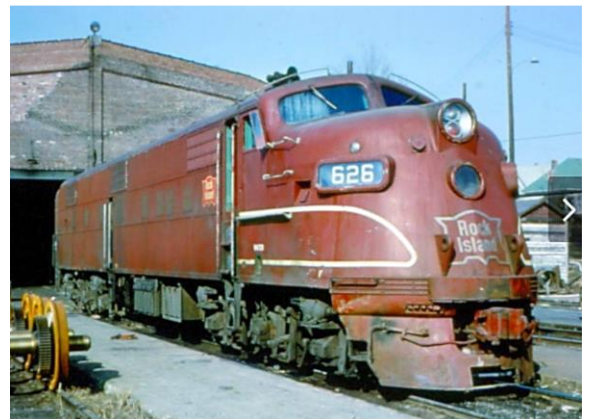
The locomotive pulling the Rocket train that wrecked in Kremlin was an [E3A diesel-electric locomotive \(# 626\)](#). Along with its twin (#625), it was built by [Electro-Motive Corporation](#) (EMC) of La Grange IL in July 1939. Locomotive 626 is shown at R at a maintenance facility in Memphis TN in February 1966.

[Locomotives 625 and 626](#) were the only E3A locomotives built for the Rock Island Railroad. They had two V-12 (12-cylinder), 6,804 cu in displacement (567 cu in displacement/cylinder) diesel engines that each produced 1,000 hp (750kW), with each engine attached to a direct-current generator that supplied power to two electric motors each - on the front and rear trucks (sets of wheels) of the locomotive.

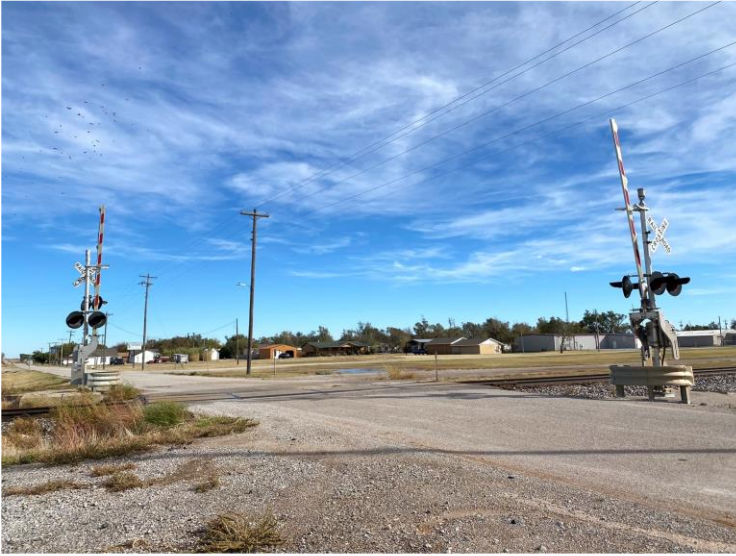
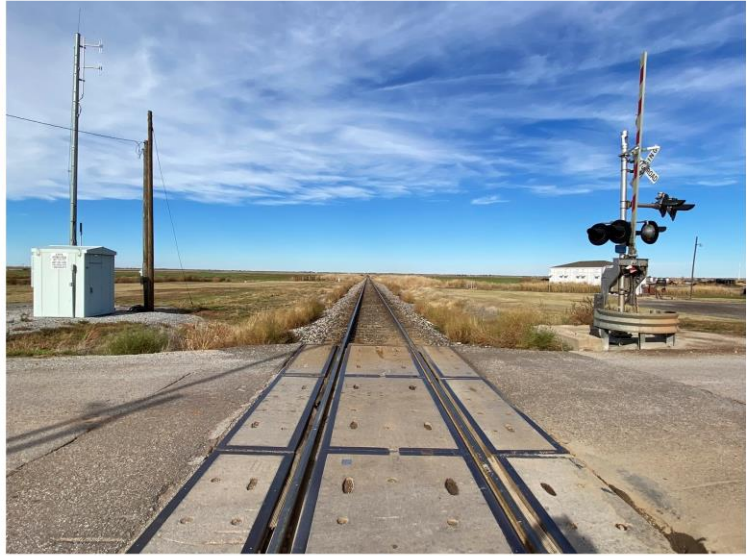
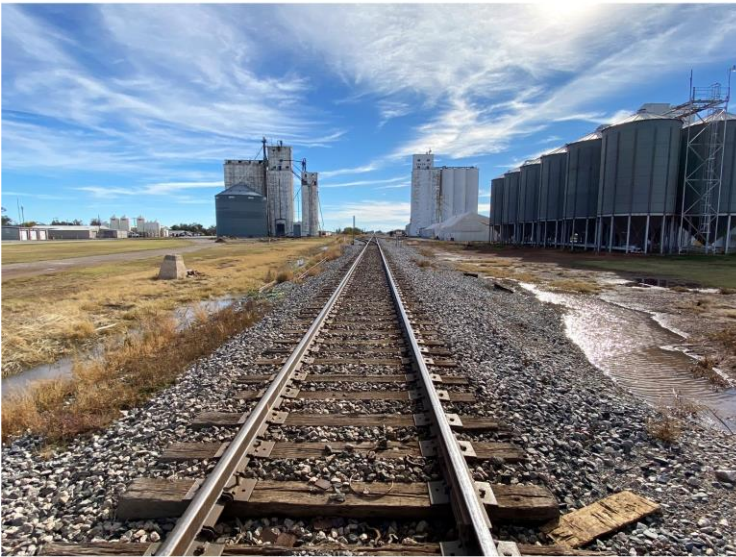
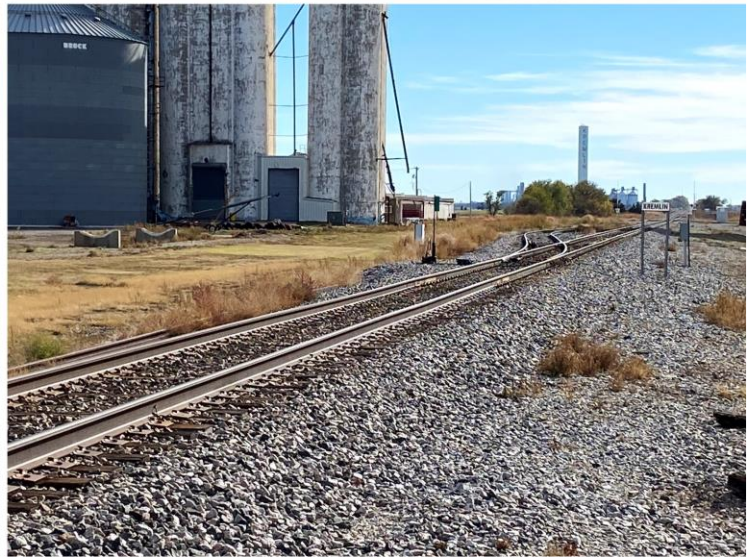
This page contains a collage of [present-day photos of the N Kremlin grade crossing](#) for orientation. Top (L): looking ESE, warning lights and crossing arms were not present in 1948, Zaloudek's stores were at rear center; (R): looking N towards Pond Creek. Bottom (L): looking S towards Enid, Farmers Grain Company elevators on L, former Zaloudek's Grain Company elevators on R; (R): looking SSE from crossing; siding (passing track) switch/junction is where most derailment took place. The freight train was in this E siding. Farmers Grain Company elevators at L, their siding no longer present. Depot was past KREMLIN sign on R.

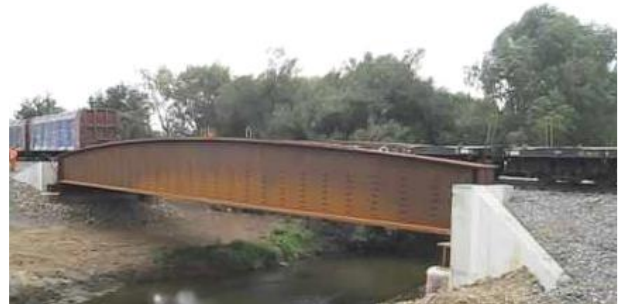
The CRIP railroad crossed **Wild Horse Creek** on **Bridge 3263**, a 50' **steel through-plate-girder open-span bridge set on two concrete abutments** (illustrative similar example in photo below), about 1600' S of where the derailment occurred.

Drainage from an area of approx. 61 sq. miles flows underneath this bridge, and to avoid 2 crossings of Wild Horse Creek during construction of the railroad bed fill in 1889, a ditch was dug to divert the stream E of the rail-bed fill. Wild Horse Creek then paralleled the railroad closely on the E for ~1600' northward. There was a second bridge (**#3260**) approx. 1800' N of Bridge 3263.

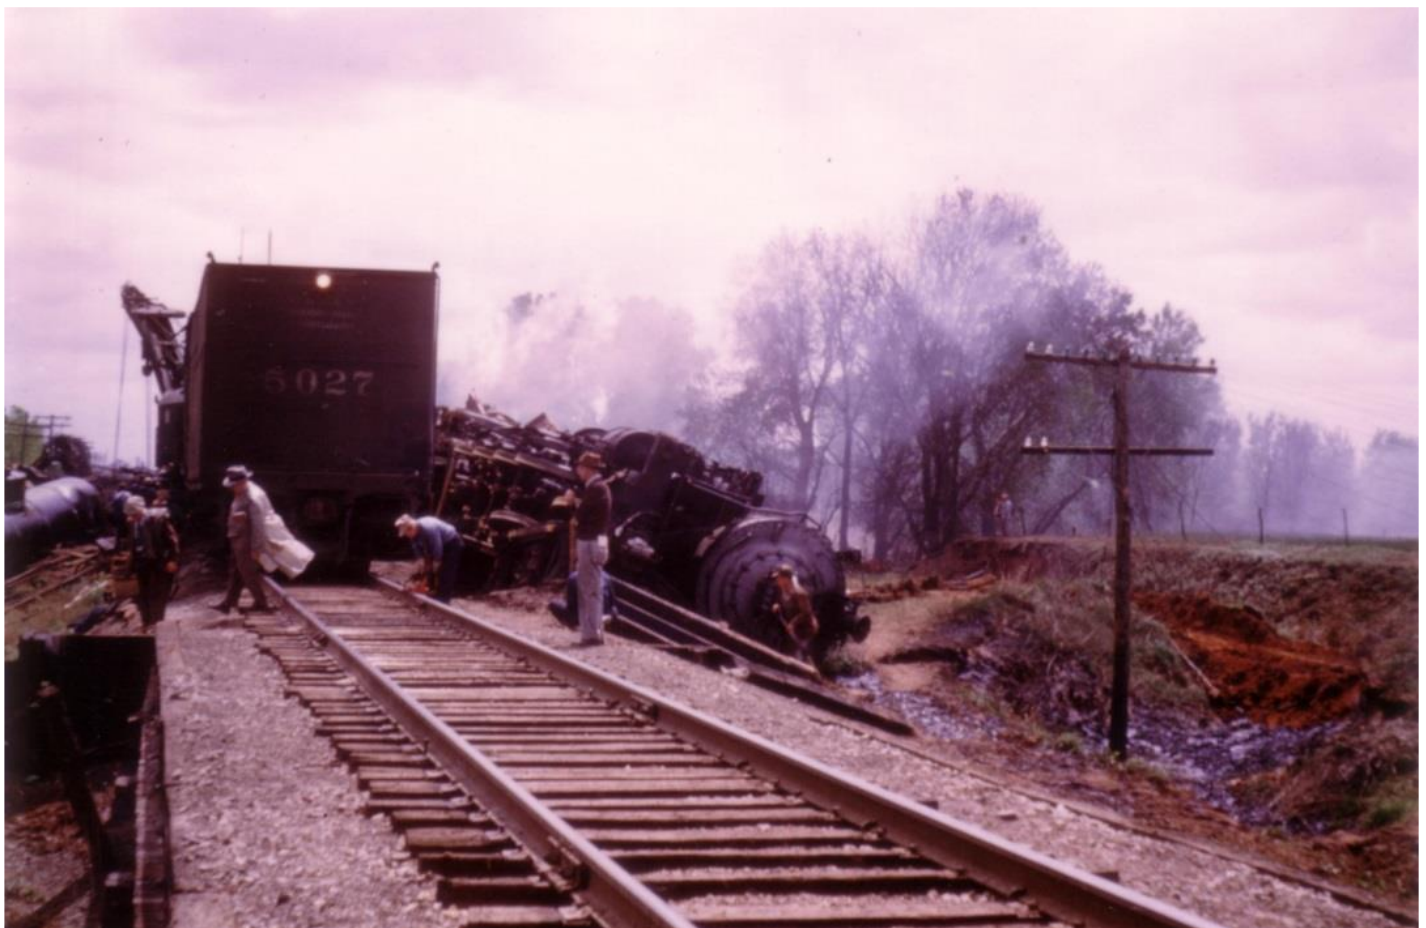
The photo below (**TOEWS FAMILY**) shows the N end of this train wreck; the photo is taken from bridge # 3260 looking S. The locomotive is overturned on its L side on the L side of the fill, and the tender, although slightly displaced to the viewer's R, is still upright. You can barely make out the engine number **5034** underneath the locomotive's headlamp. The diverted Wild Horse Creek would be at far L. This view fits both maps quite well.

CRIP Extra 5034 North, consisted of **Engine 5034**, 52 cars, and a caboose. Engine 5034 was a **4-8-4-type steam locomotive**, and the combined weight of engine and tender was 776,700 lbs. The engineman, fireman, and front brakeman were in the locomotive and the conductor and flagman were in the cupola of the caboose. The freight train passed Enid OK at 7:35 PM and at **8:07 PM**, while moving at an estimated 50 mph **4.73 miles N of the Kremlin depot**, the **first 29 cars and cars 38-43 derailed**. The engine ended up on its L side on the L (W) side of the rail-bed fill. The tender was separated from the engine and was stopped upright and off its trucks, about 18' S of the locomotive. Both were badly damaged. The first 29 cars stopped in various positions near the point of the accident while the 38th-43rd cars buckled and overturned at various positions on the fill. **The flammable contents of the cars at the front of the train ignited and 27 cars were destroyed in the fire**. The other cars were badly damaged.

The **fireman and front brakeman were killed**, and the **engineman, conductor and flagman were injured**. The engineman was the only survivor aboard the locomotive.

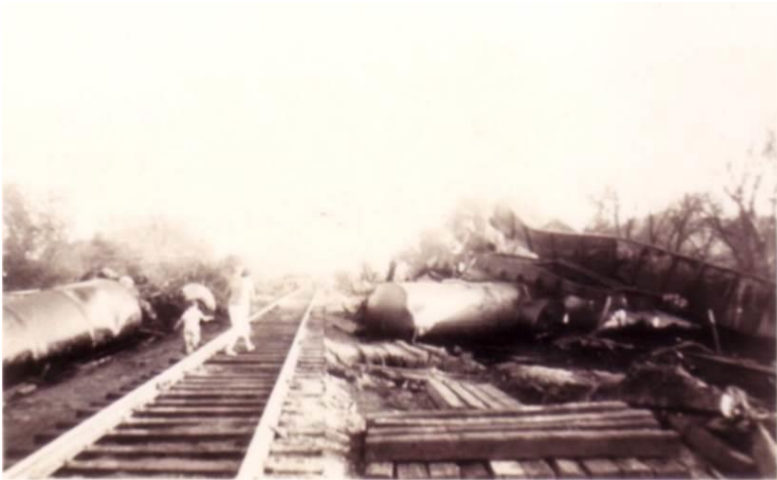
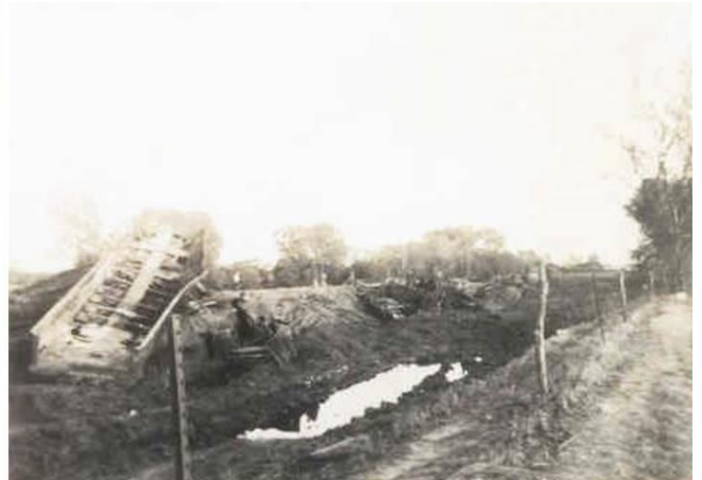
We believe these two photos are also of this train wreck - the general setting and topography agree with what is known.

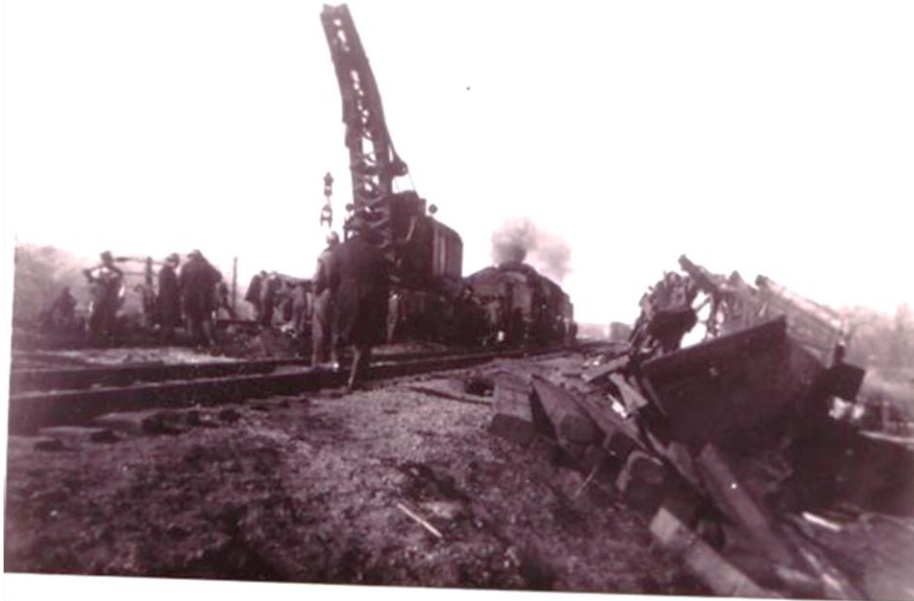
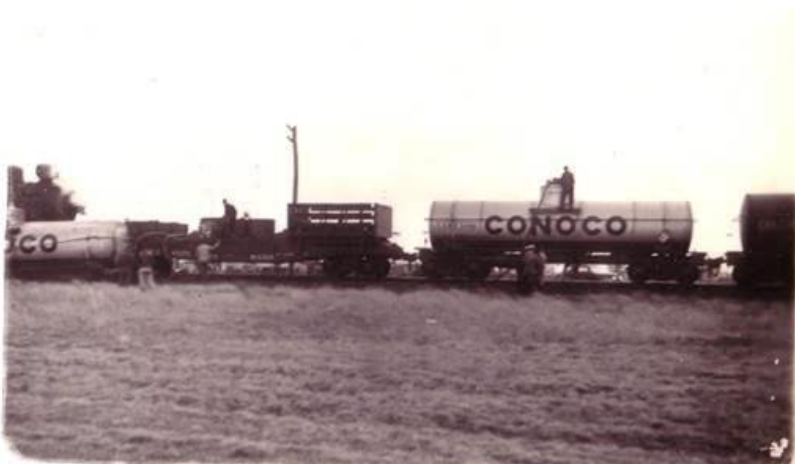
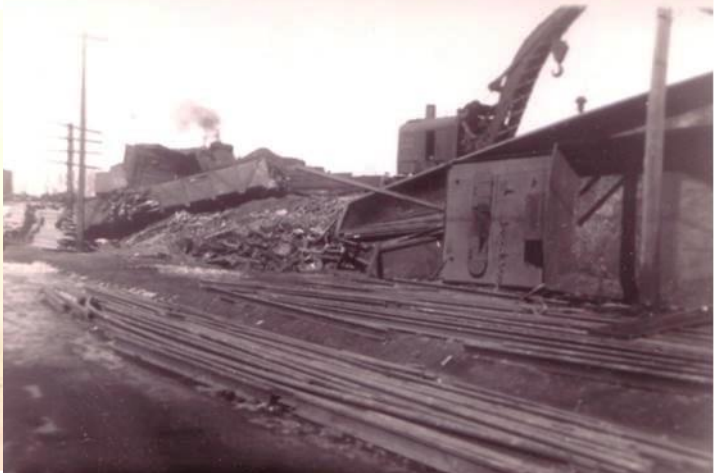
The three photos below seem to also be from this accident. The photos match the scene above quite well. Note positions of crane, salvage train, and railcar debris below and at lower R. They are all from a single page of an old [Toews Family photo album](#).

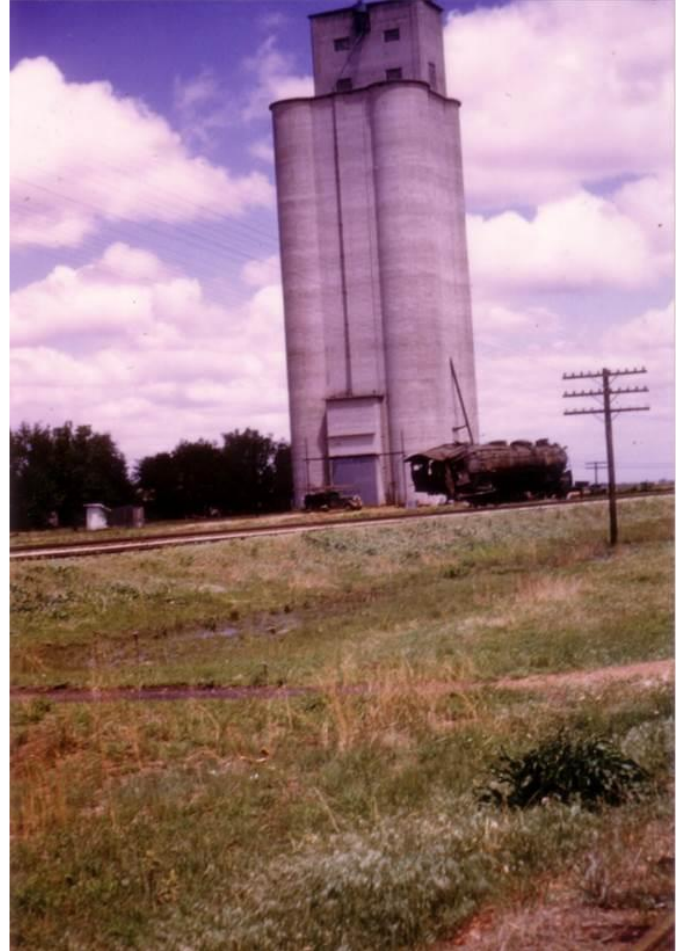
The photo below shows the **damaged steam locomotive #5034** in the siding by Zaloudek's **elevator**. This color photo seems to pair with the color photo on page 25. The two color photos are a set provided by **Gerry Toews Reimer**, so originally from her father, Kremlin banker (& our Uncle) **Henry G Toews**.

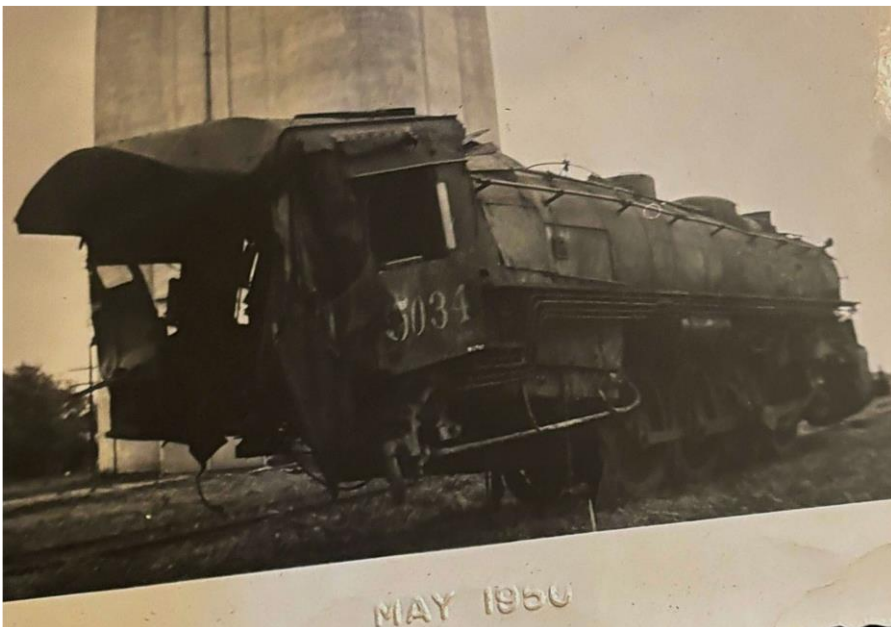
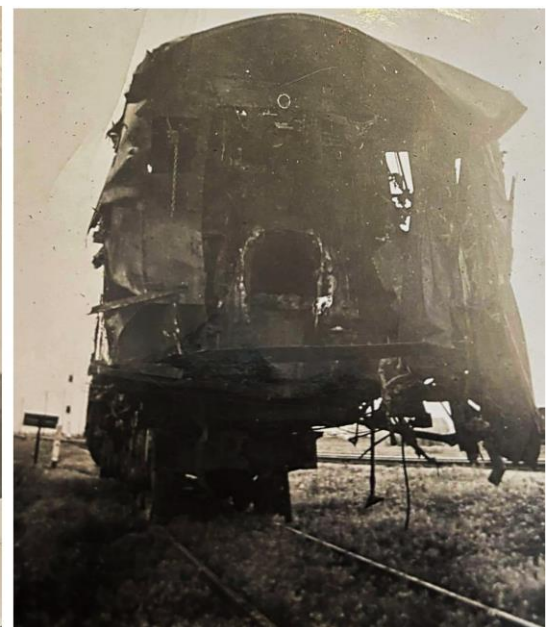
Additional photos of **Locomotive #5034** adjacent to Zaloudek's Elevator in Kremlin shown below are from **Fred Randolph Family** photo album generously provided by **Betty Randolph Strickland**. They clearly show the same severely damaged locomotive from this single-train derailment/fire.
